# ST. IGNATIUS CHURCH EXTERIOR RESTORATION - PHASE 2

ISSUED FOR CONSTRUCTION - 04/16/2026

**PHASE 2 SCOPE OF WORK INCLUDES THE REMAINING BUILDING FAÇADES NOT INCLUDED IN PHASE 1. REFER TO THE DRAWINGS FOR ADDITIONAL INFORMATION.**

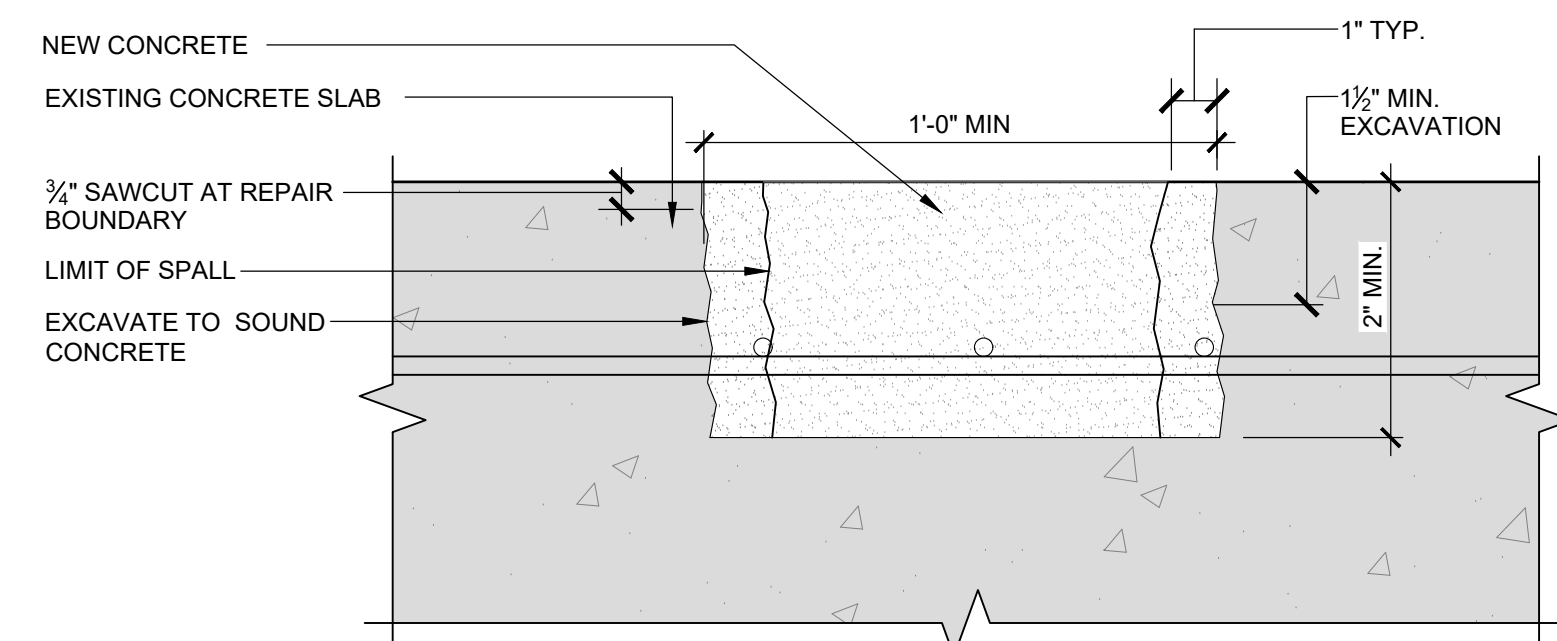
**NOTE:**  
1. REPAIR AREA SHOULD BE NO LESS THAN 3/4" IN DEPTH - TYP.  
2. REMOVE ALL RUST AND CONTAMINANTS FROM EXPOSED STEEL REBAR AND SPLICE IN NEW STEEL WHERE MORE THAN 10% OF THE REBAR'S CROSS SECTION HAS DETERIORATED. APPLY 2 COATS OF ANTI-CORROSION AGENT W/ STIFF BRISTLE BRUSH.

**5 TYPICAL PARTIAL DEPTH CONCRETE SLAB REPAIR**  
3"=1'-0"

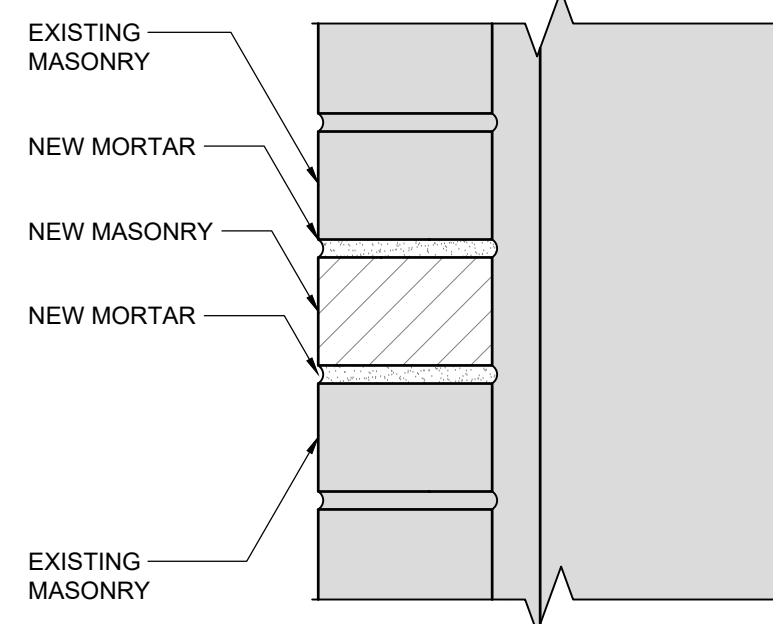
- MASONRY SURFACES IN THE WALL SHOULD BE DAMPENED BEFORE THE NEW UNITS ARE PLACED BUT THE MASONRY SHOULD ABSORB ALL SURFACE MOISTURE TO ENSURE A GOOD BOND. THE APPROPRIATE SURFACES OF THE SURROUNDING MASONRY WORK AND THE REPLACEMENT MASONRY UNIT SHOULD BE BUTTERED WITH MORTAR. IF CELL(S) IN UNIT WERE SOLID-FILLED WITH MORTAR, THEN THE NEW SHALL BE SOLID-FILLED WITH MORTAR. THE REPLACEMENT MASONRY UNIT SHOULD BE CENTERED IN THE OPENING AND PRESSED INTO POSITION. THE EXCESS MORTAR SHOULD BE REMOVED WITH A TROWEL. POINTING AROUND THE REPLACEMENT UNIT WILL HELP TO ENSURE FULL HEAD AND BED JOINTS. WHEN THE MORTAR BECOMES "THUMBPRINT" HARD, THE JOINTS SHOULD BE TOOLED TO MATCH THE ORIGINAL PROFILE.

**2. BRICK AND MORTAR REPLACEMENT - SECTION VIEW**

**1. BRICK AND MORTAR REPLACEMENT - ELEVATION VIEW**

NOTE: DO NOT DAMAGE EXISTING ADJACENT MASONRY TO REMAIN.

**8 MASONRY UNIT AND MORTAR REPLACEMENT**

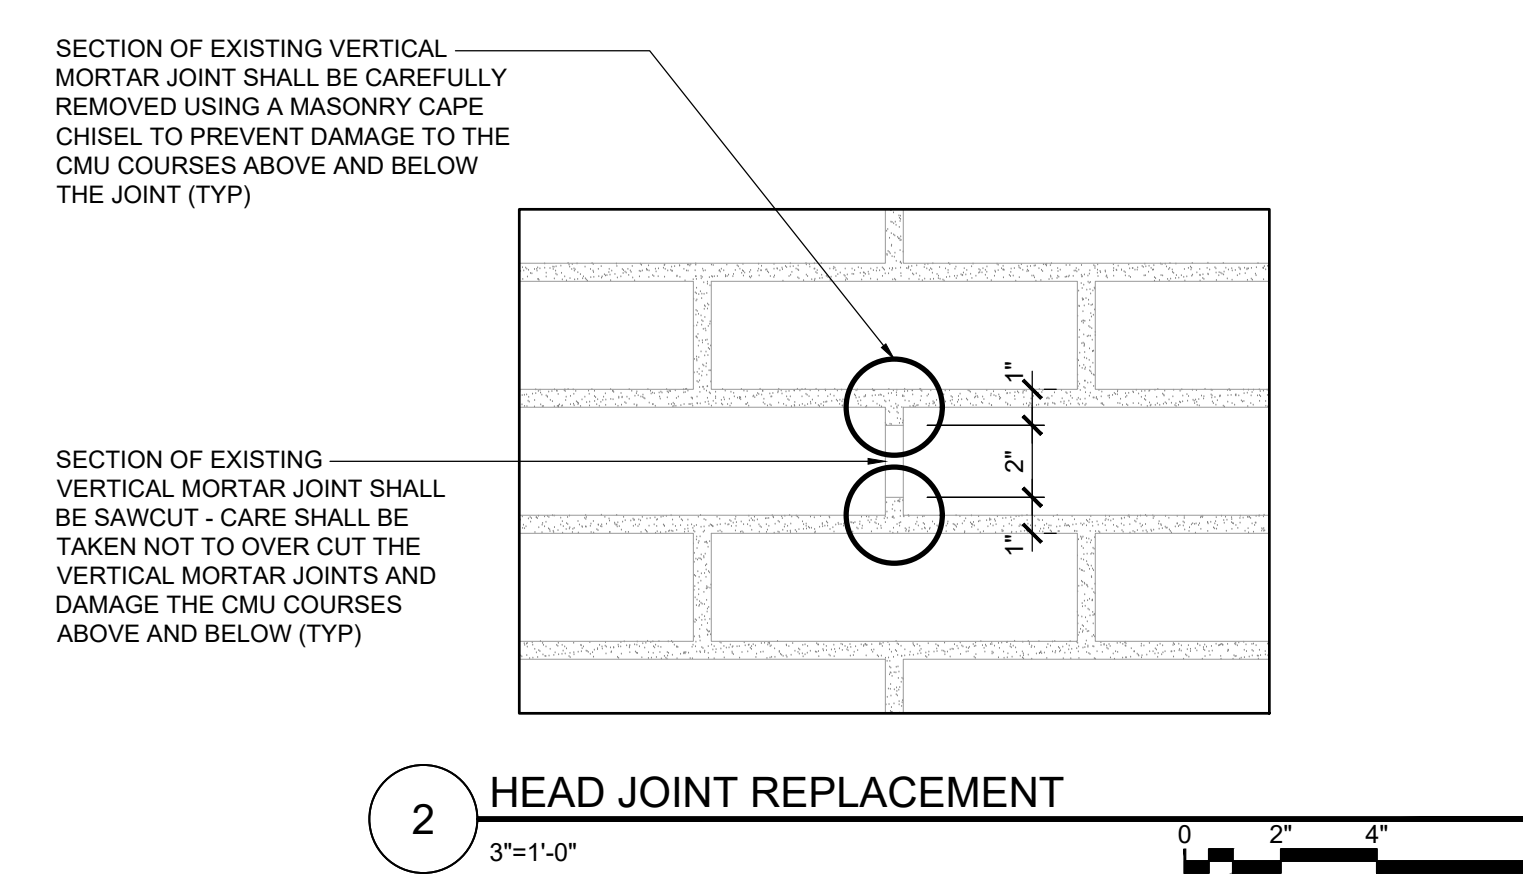
**2 HEAD JOINT REPLACEMENT**  
3\"/>

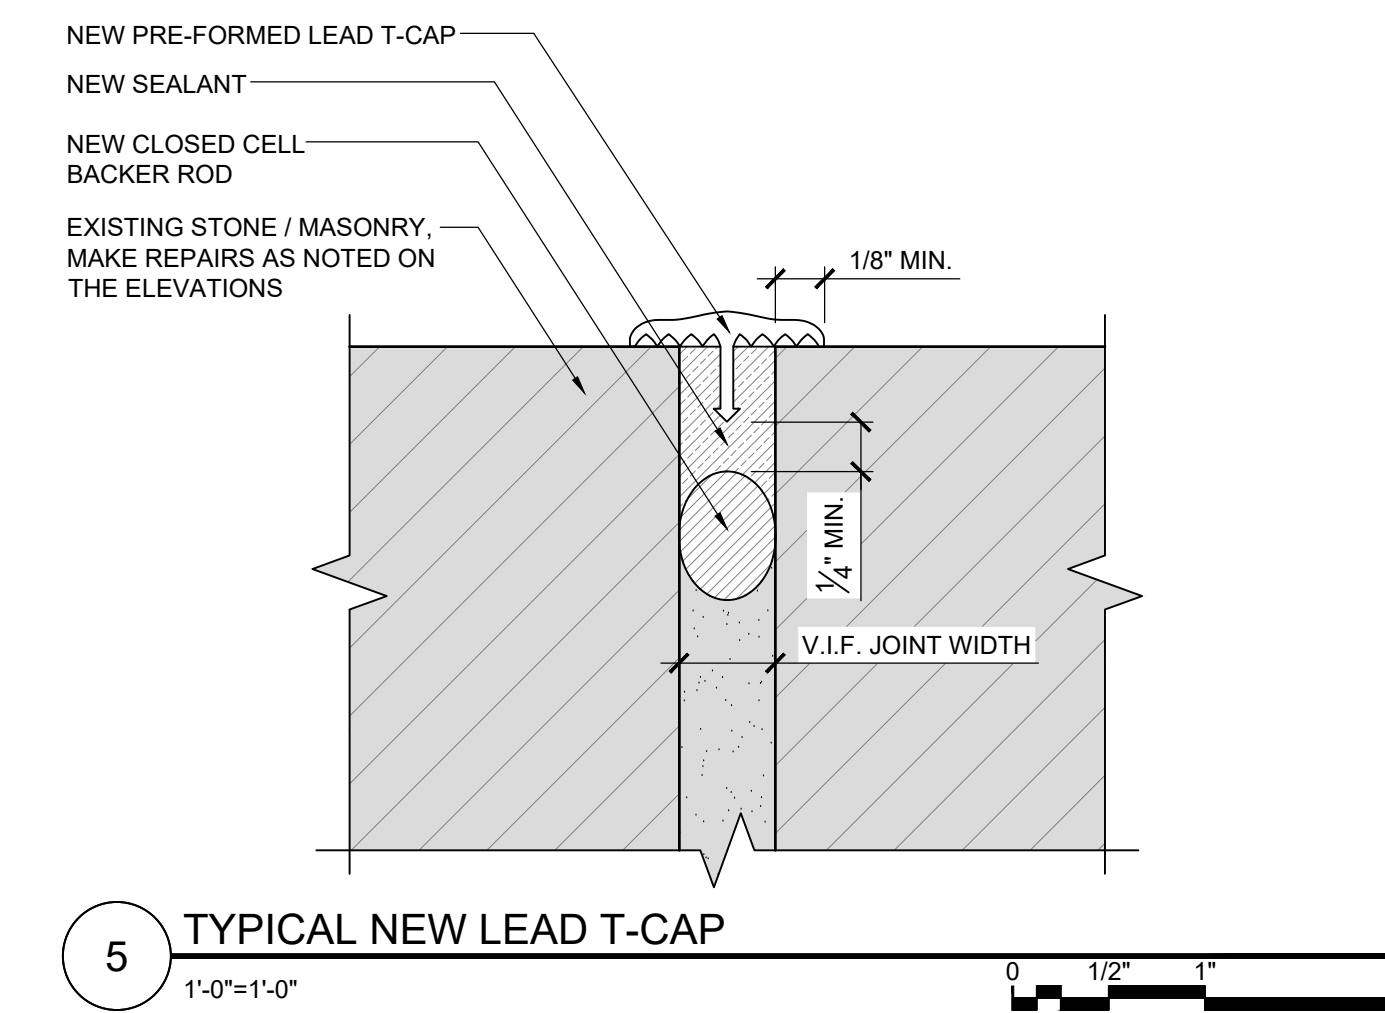
**5 TYPICAL NEW LEAD T-CAP**  
1\"/>

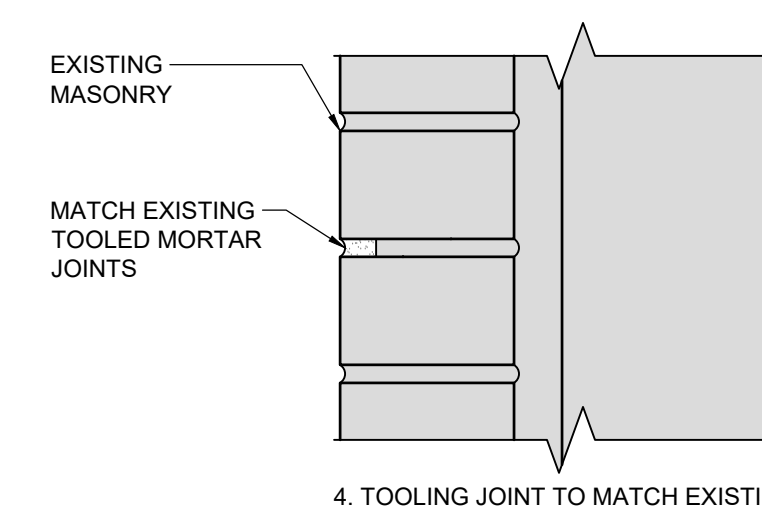
**1. DETERIORATED MORTAR JOINT**

**2. MORTAR CUT BACK TO A UNIFORM DEPTH**

**3. PLACE POINTING MORTAR**

**4. TOOLING JOINT TO MATCH EXISTING MORTAR JOINT PROFILE (TYP)**

**MORTAR REPAIR NOTES:**  
EXISTING MORTAR SHALL BE CUT OUT BY MEANS OF A PLUGGING CHISEL OR CAPE CHISEL OR A SPECIAL POINTER'S GRINDER TO A DEPTH OF 2 TO 2-1/2 TIMES THE WIDTH OF THE JOINTS (3/4\"/>

**1 MORTAR REPAIR DETAIL (TYP.)**  
3\"/>
