ST. IGNATIUS CHURCH EXTERIOR RESTORATION PHASES 2 AND 3

28 COMMONWEALTH AVENUE, CHESTNUT HILL, MA 02467

ISSUED FOR PERMIT - 05/28/2026

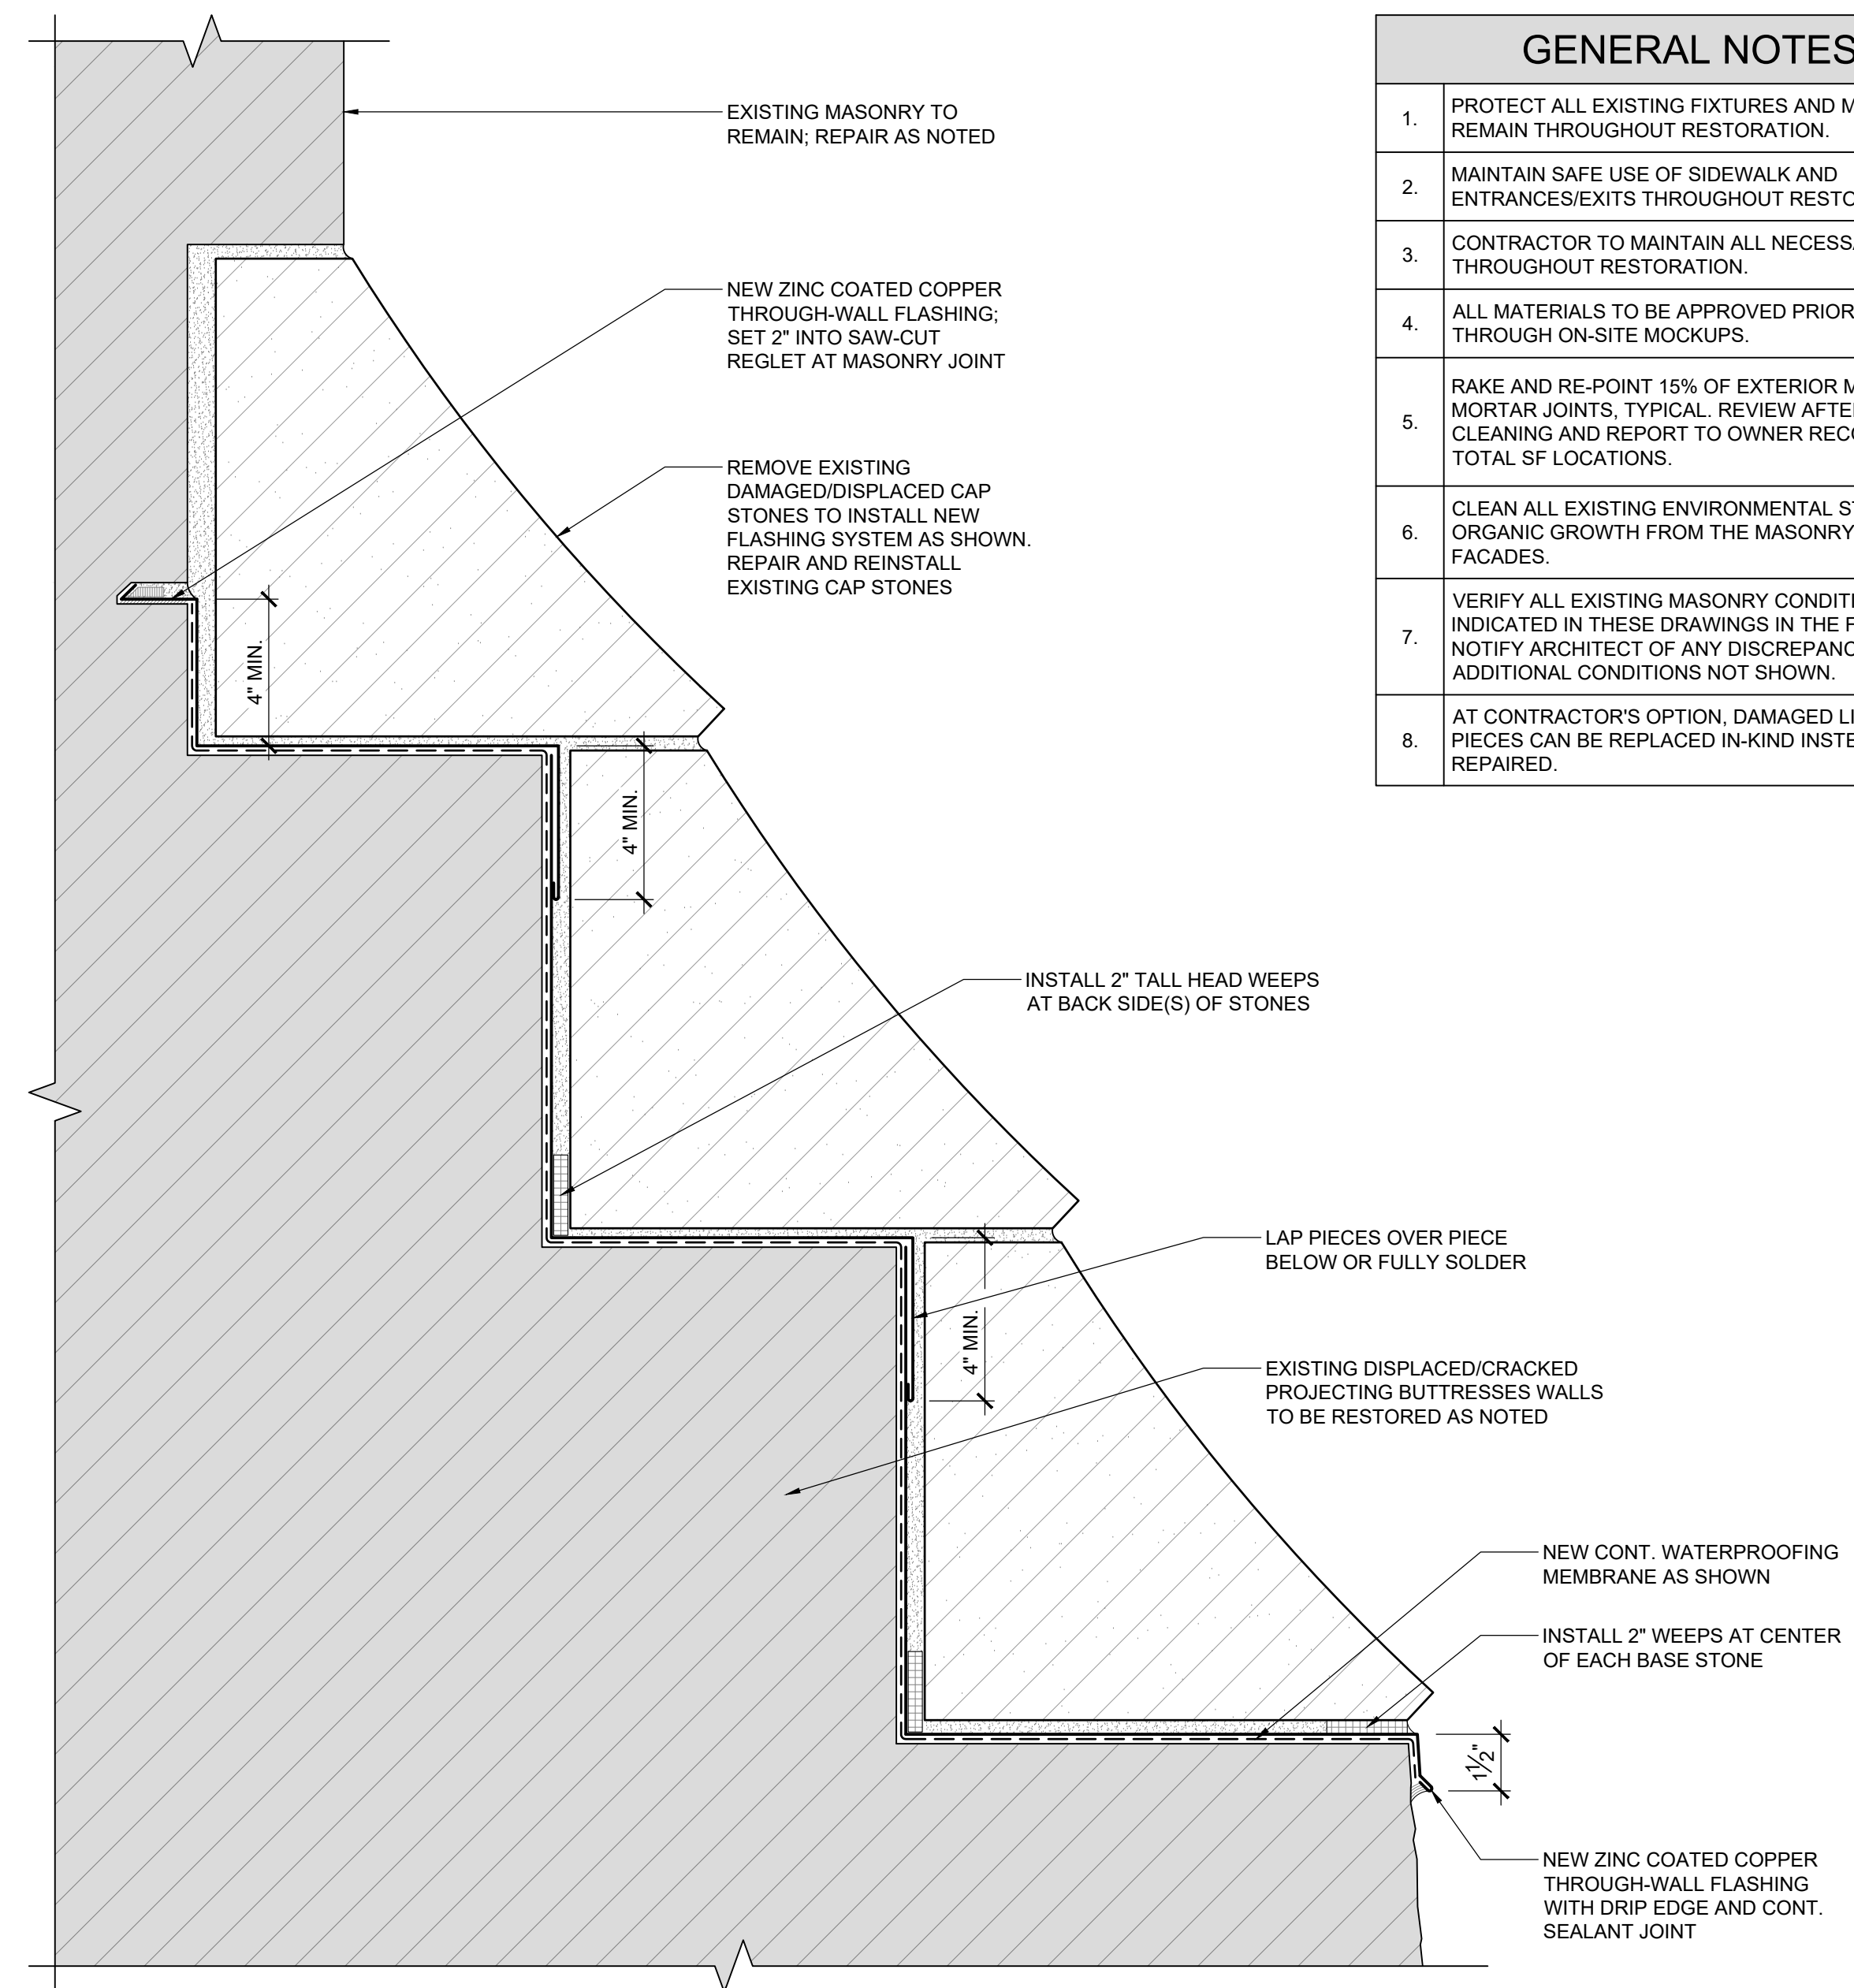
3 NEW THROUGH-WALL FLASHING AT EXISTING PROJECTING BUTTRESSES CAP STONES
3"=1'-0"

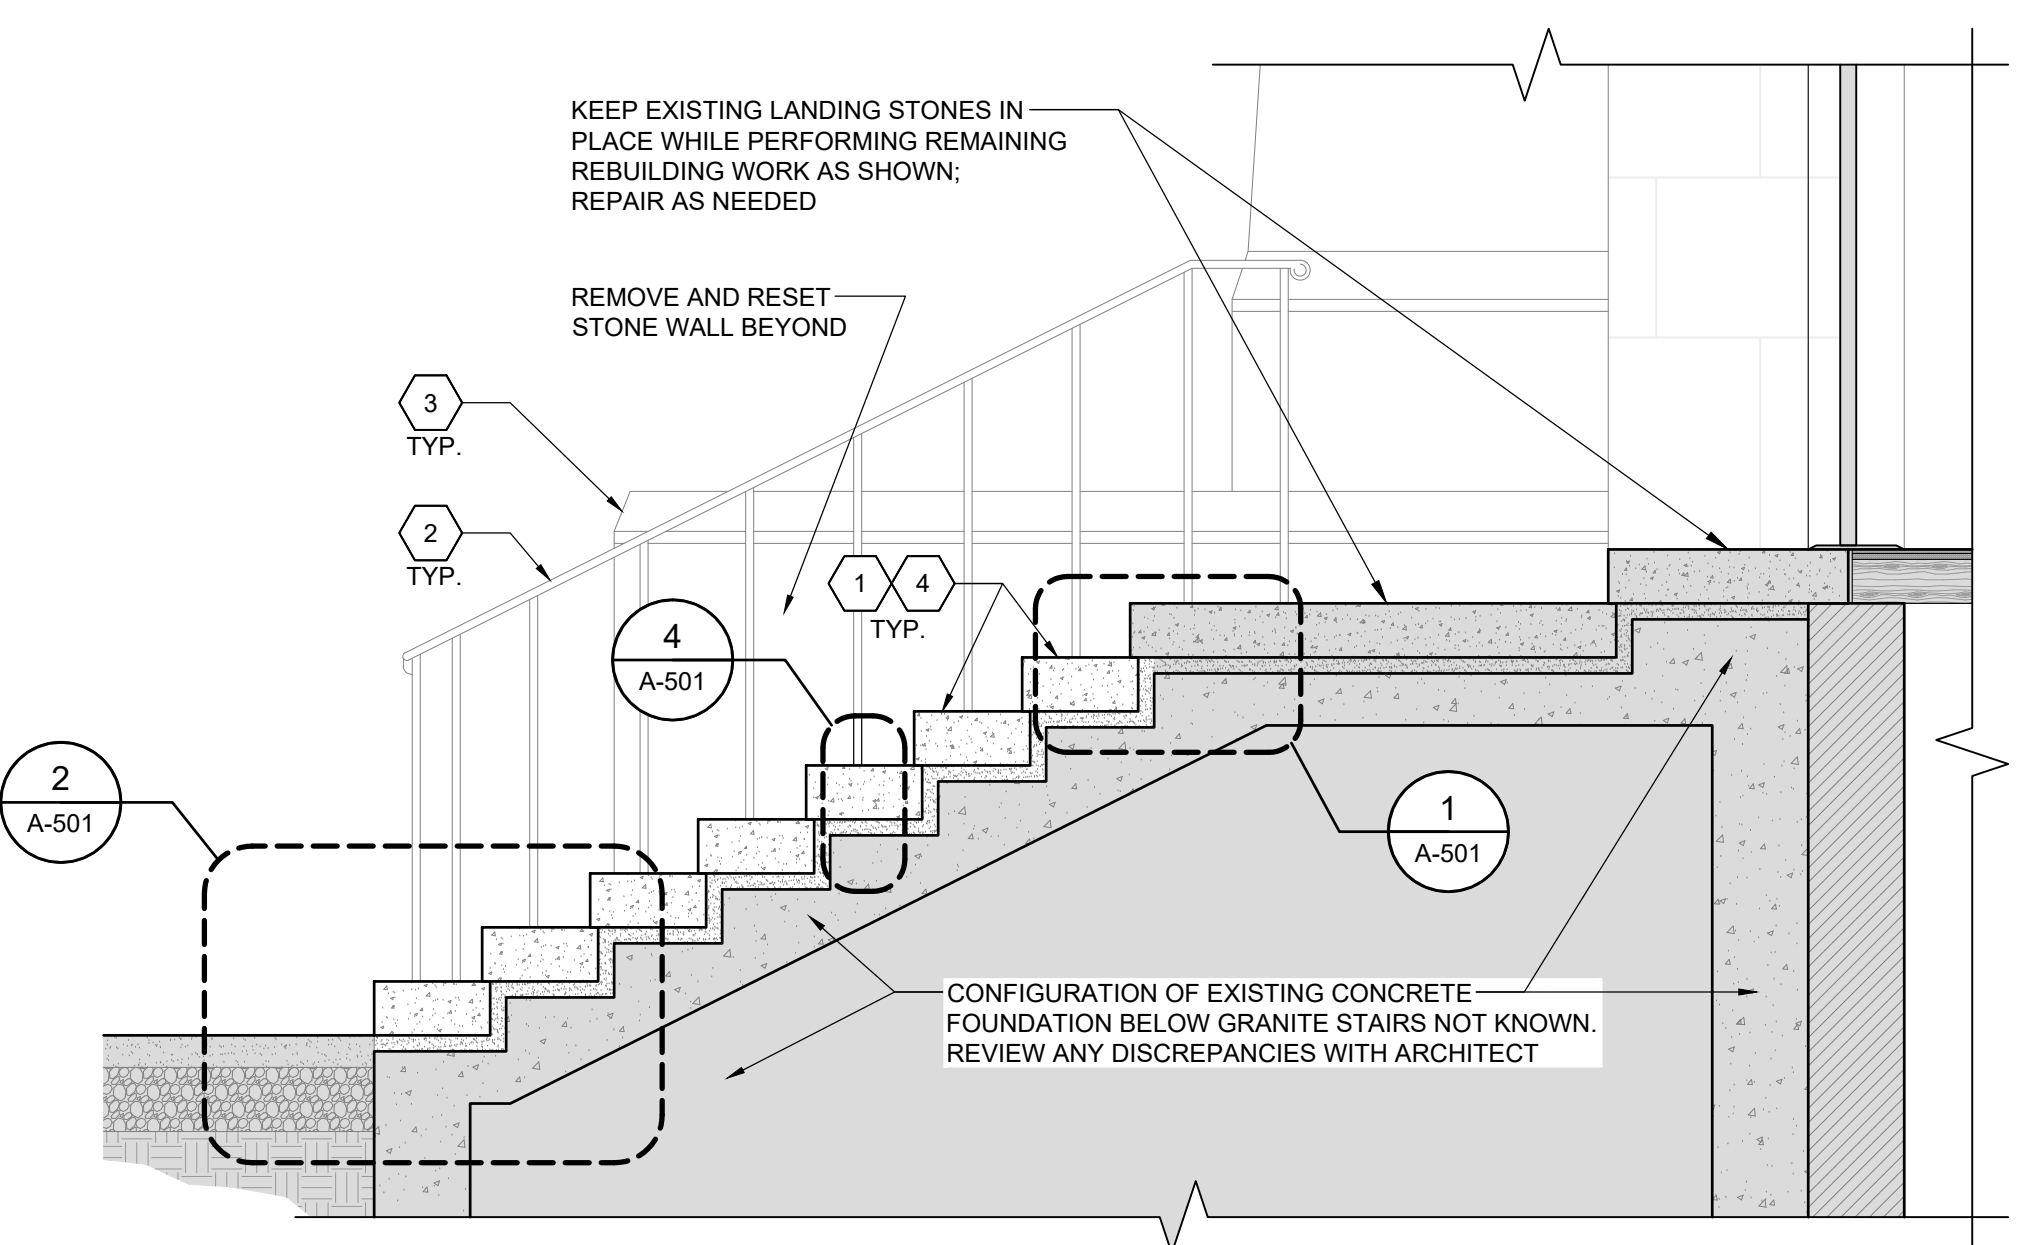
2 EXISTING SOUTH ENTRANCE STAIR SECTION
1/2"=1'-0"

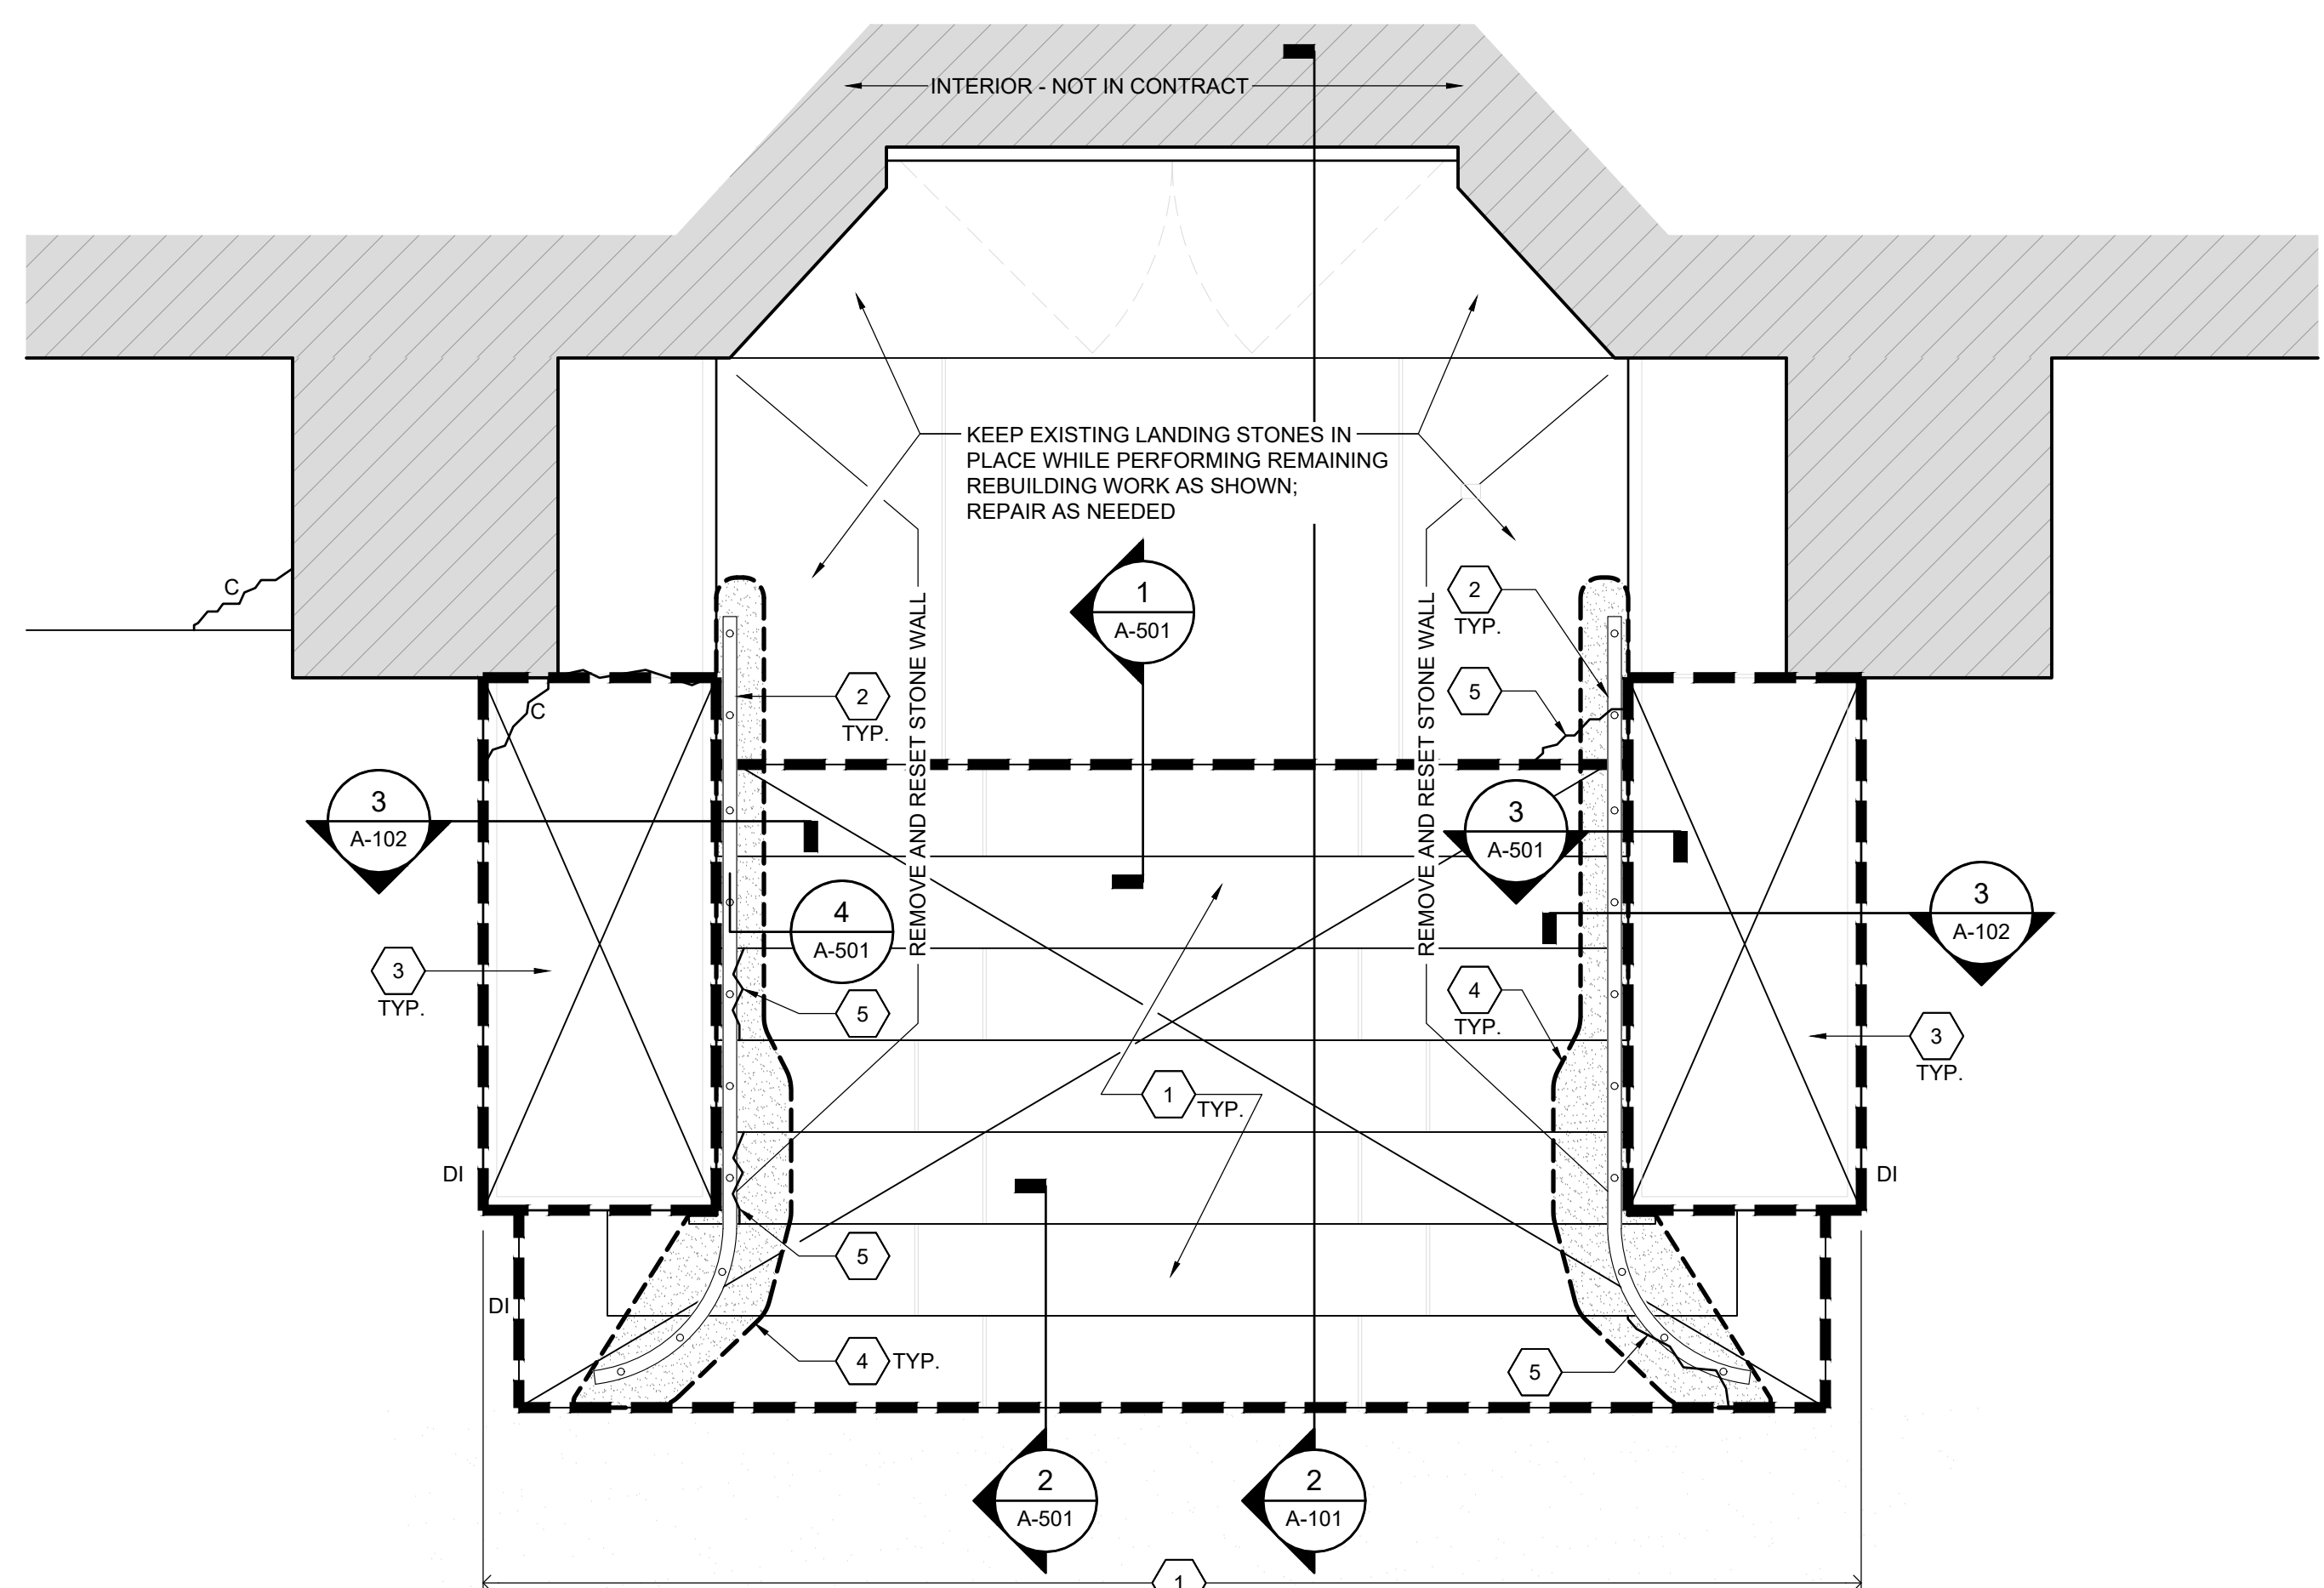
1 EXISTING SOUTH ENTRANCE PLAN
1/2"=1'-0"

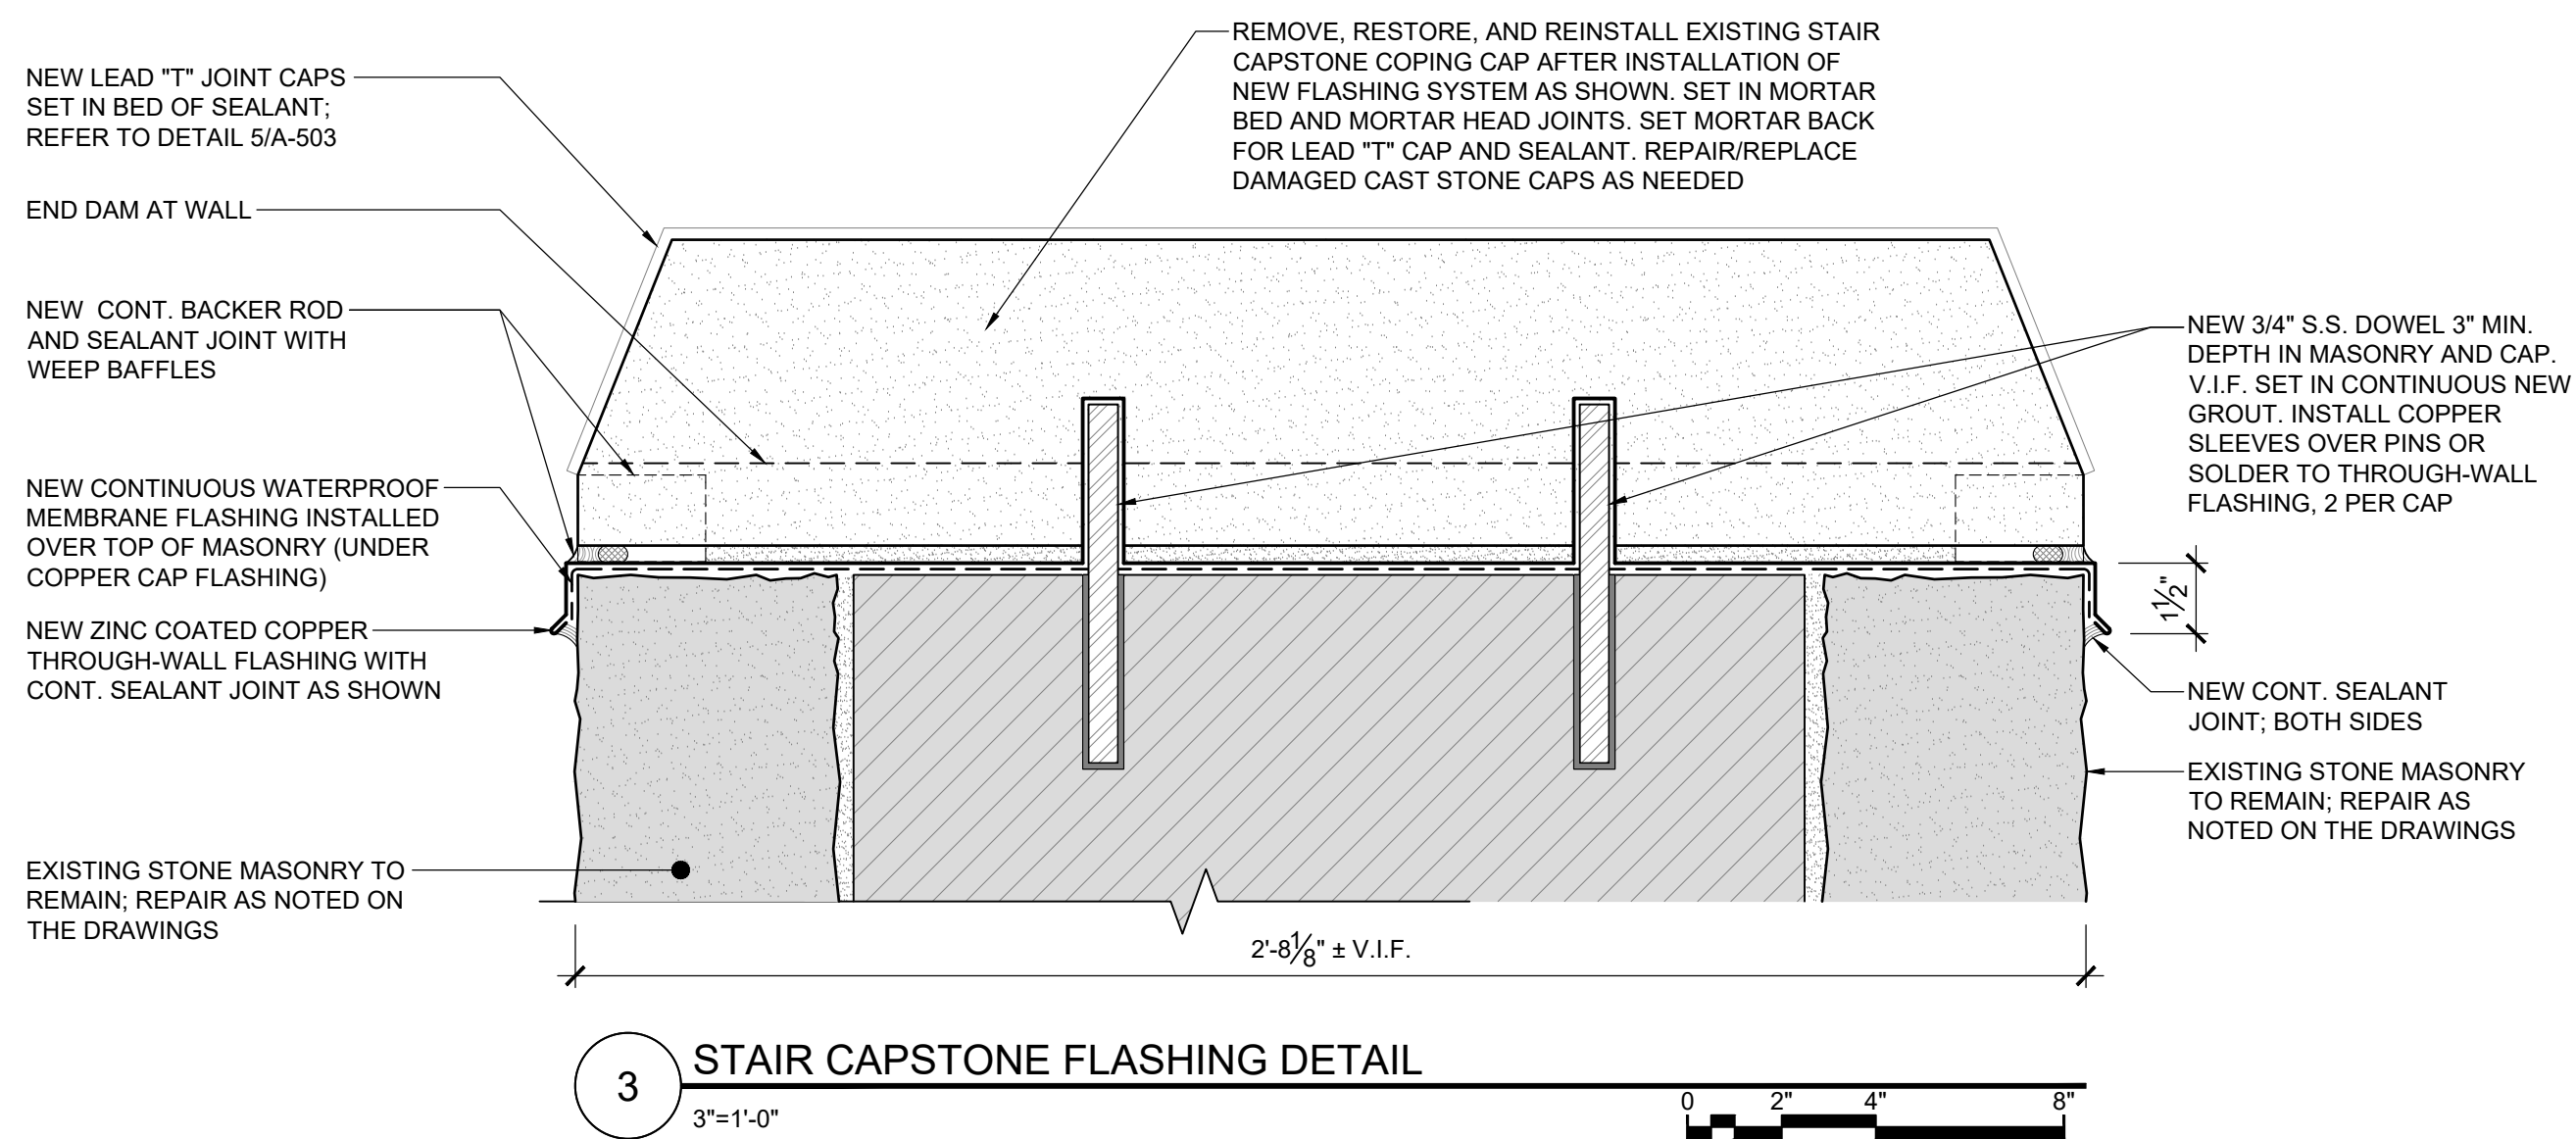
3 STAIR CAPSTONE FLASHING DETAIL
3"=1'-0"

8. AT CONTRACTOR'S OPTION, DAMAGED LIMESTONE PIECES CAN BE REPLACED IN-KIND INSTEAD OF REPAIRED.	RECONSTRUCT DISPLACED MASONRY AT SIDE WALLS OF STAIR AND RE-POINT WALL. RESET CAP STONES WITH NEW THROUGH-WALL FLASHING. REFER TO DETAIL 3/A-102 SIM. EXCAVATE BACK SIDE OF WALL AND WATERPROOF WITH TREMCO TREMPROOF 250G. RE-GRADE AWAY FROM WALL.	EXISTING ABANDONED ANCHOR TO BE REMOVED AND THE HOLE FILLED WITH REPAIR MATERIAL.	7. CLEANING MATERIALS: PROVIDE CLEANING MATERIALS FROM PROSOCO, INC. OR APPROVED PRODUCTS BY CATHEDRAL STONE OR EDISON COATINGS, INC. - GENERAL CLEANING: EK RESTORATION CLEANER - RESISTANT STAIN CLEANING: HEAVY DUTY RESTORATION CLEANER - IRON STAIN CLEANING: SURE KLEAN FERROUS STAIN REMOVER - EFFLORESCENCE CLEANING: SURE KLEAN WHITE SCUM REMOVER - ASPHALT AND TAR REMOVER: SURE KLEAN ASPHALT AND TAR REMOVER - OTHER CLEANING PRODUCTS AS RECOMMENDED BY MANUFACTURER'S REP FOR SPECIFIC STAINS ENCOUNTERED IN THE AREA OF WORK.

5. RAKE AND RE-POINT 15% OF EXTERIOR MASONRY MORTAR JOINTS. TYPICAL REVIEW AFTER INITIAL CLEANING AND REPORT TO OWNER RECOMMENDED TOTAL SF LOCATIONS.	EXISTING RAILINGS. PERFORM REPAIR WORK AT STAIRS AND CONCRETE RAMPS AS NOTED. RESTORE EXISTING RAILINGS WITH NEW COLOR GALVANIZED POST BASES. REFER TO SHEET A-501 FOR ADDITIONAL INFORMATION.	EXISTING DISPLACED MASONRY OR LIMESTONE; CAREFULLY REMOVE AND REINSTALL MASONRY OR LIMESTONE UNITS. INSTALL S.S. WALL TIES AT 16" O.C. EACH WAY, AND STAINLESS STEEL DOWELS AS SHOWN ON 3/A-102.

7. VERIFY ALL EXISTING MASONRY CONDITIONS INDICATED IN THESE DRAWINGS IN THE FIELD, AND NOTIFY ARCHITECT OF ANY DISCREPANCIES OR ADDITIONAL CONDITIONS NOT SHOWN.	RECONSTRUCT DISPLACED MASONRY AT SIDE WALLS OF STAIR AND RE-POINT WALL. RESET CAP STONES WITH NEW THROUGH-WALL FLASHING. REFER TO DETAIL 3/A-102 SIM. EXCAVATE BACK SIDE OF WALL AND WATERPROOF WITH TREMCO TREMPROOF 250GCG. RE-GRADE AWAY FROM WALL.	EXISTING LOOSE CLAY TILE SHINGLE TO BE REMOVED AND REINSTALLED.

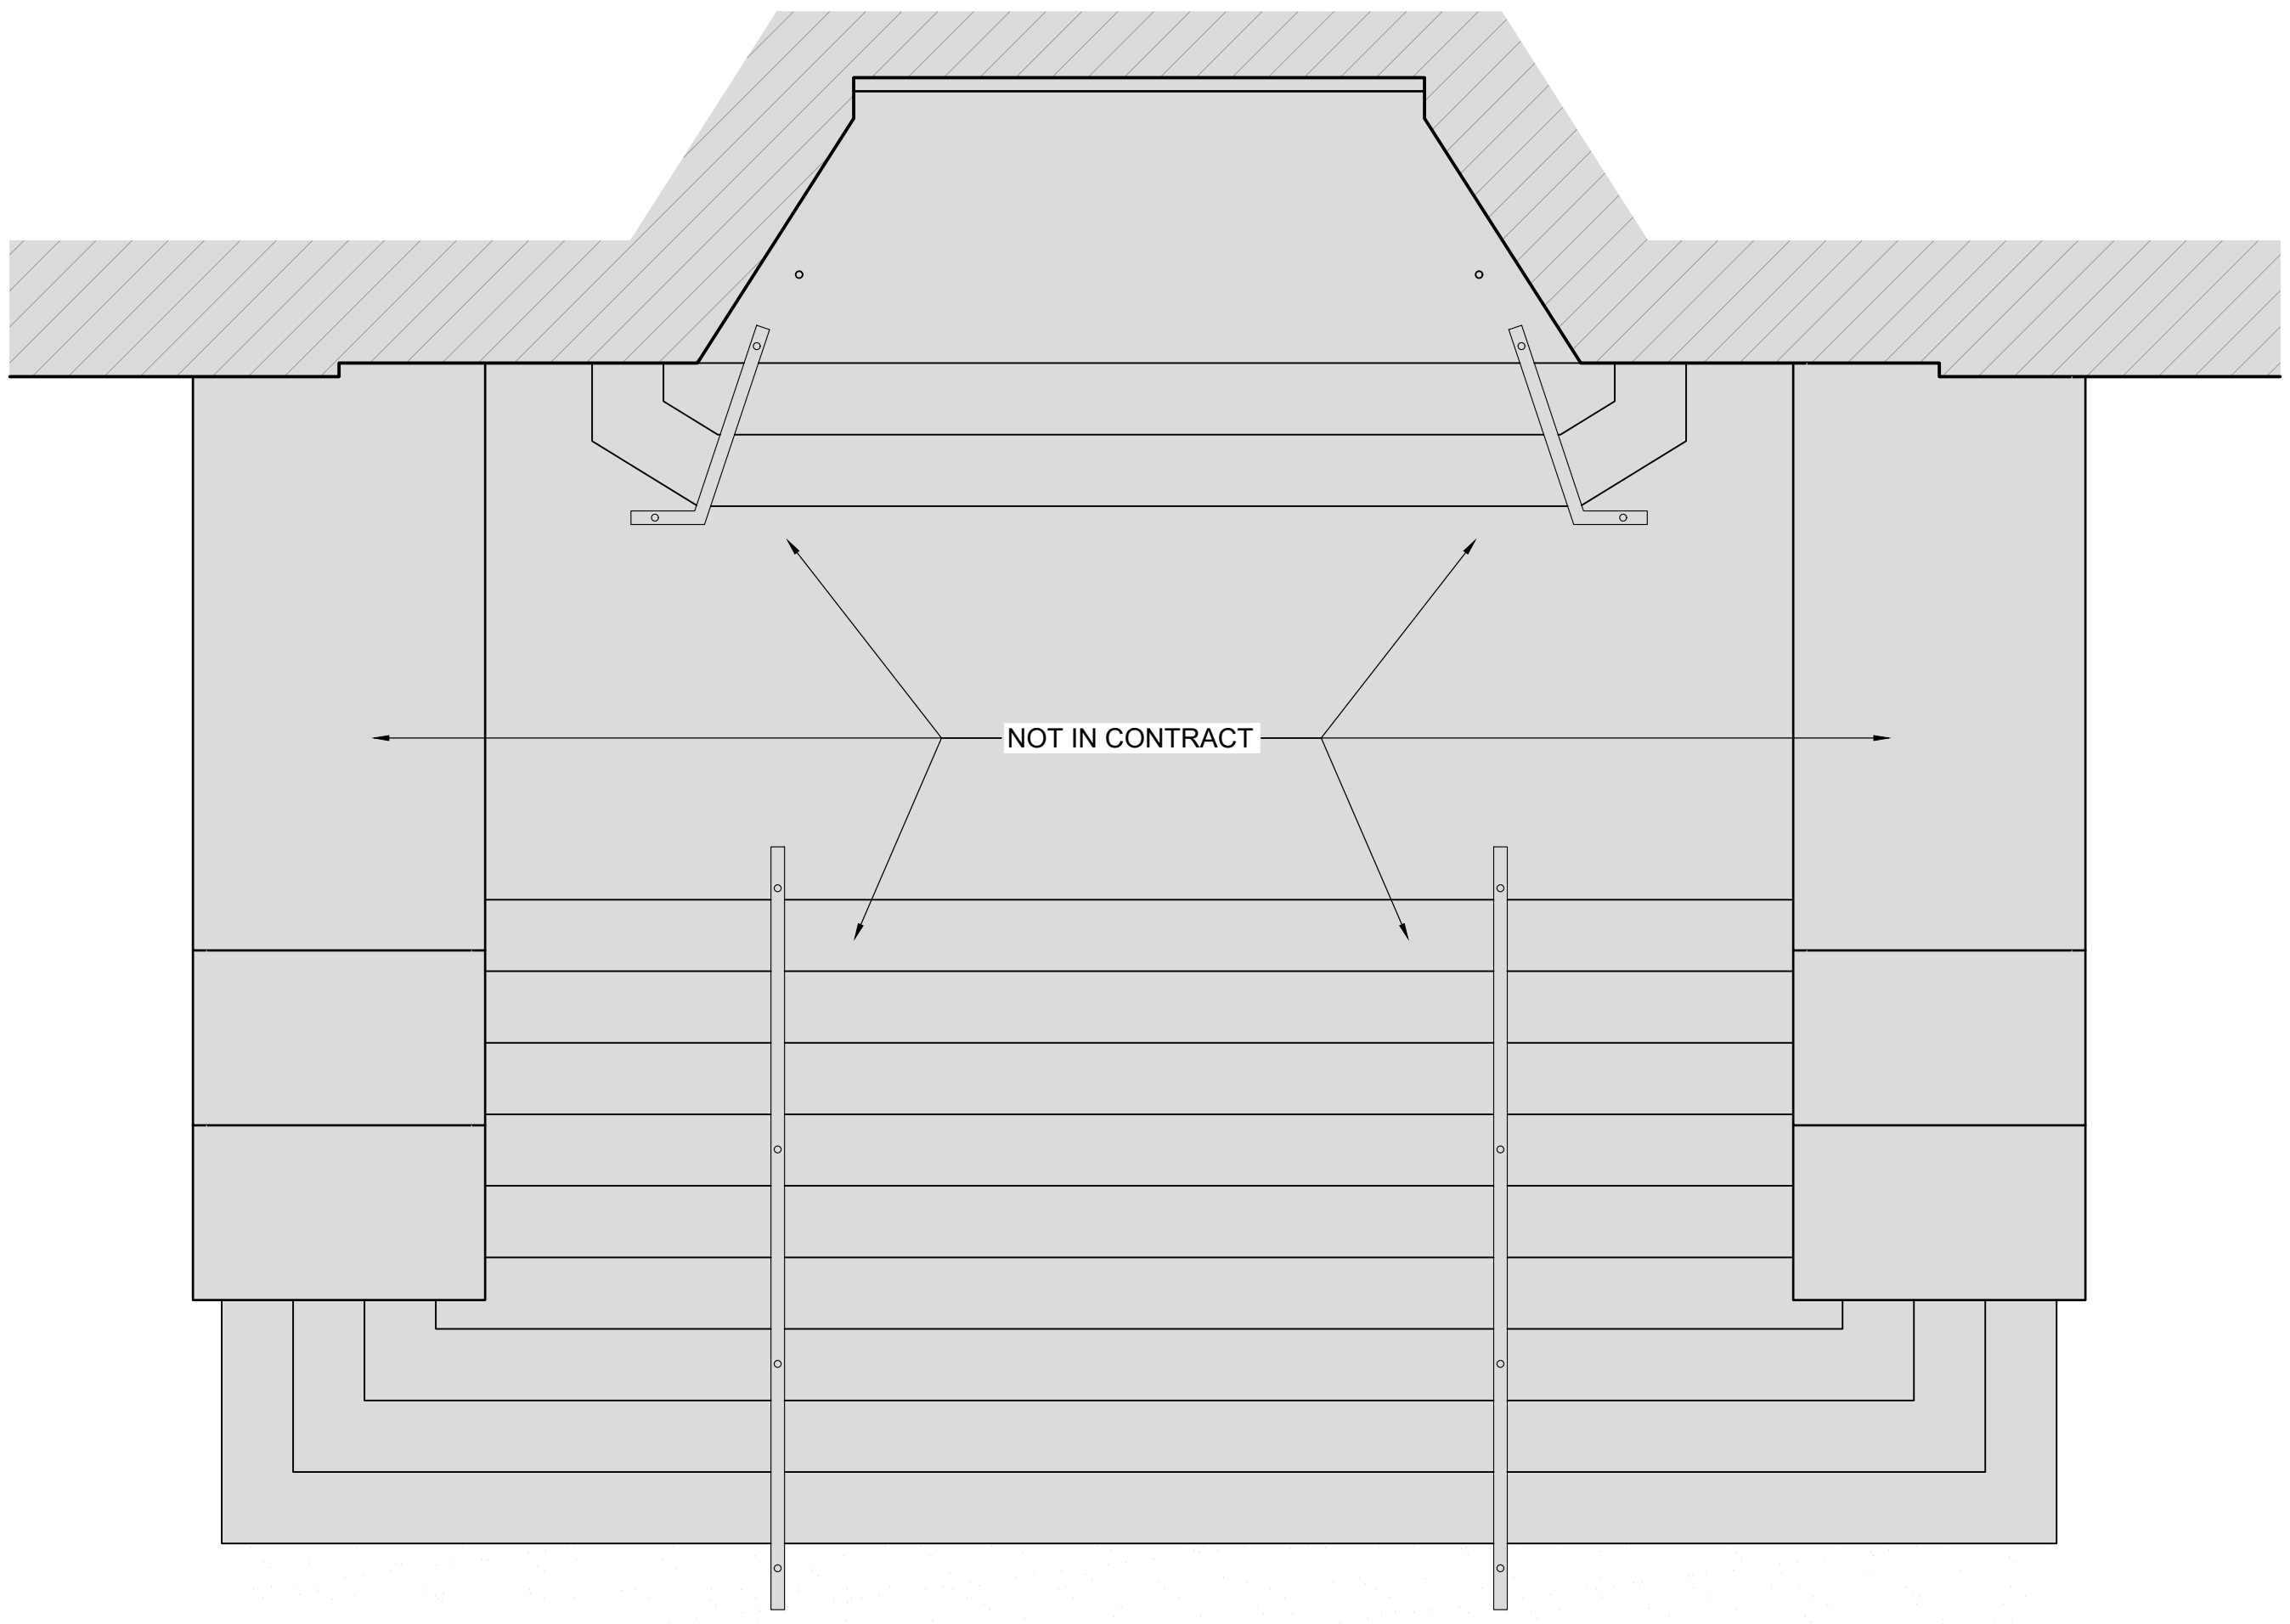
1 EXISTING EAST ENTRANCE PLAN - N. I. C.
1/2"=1'-0"

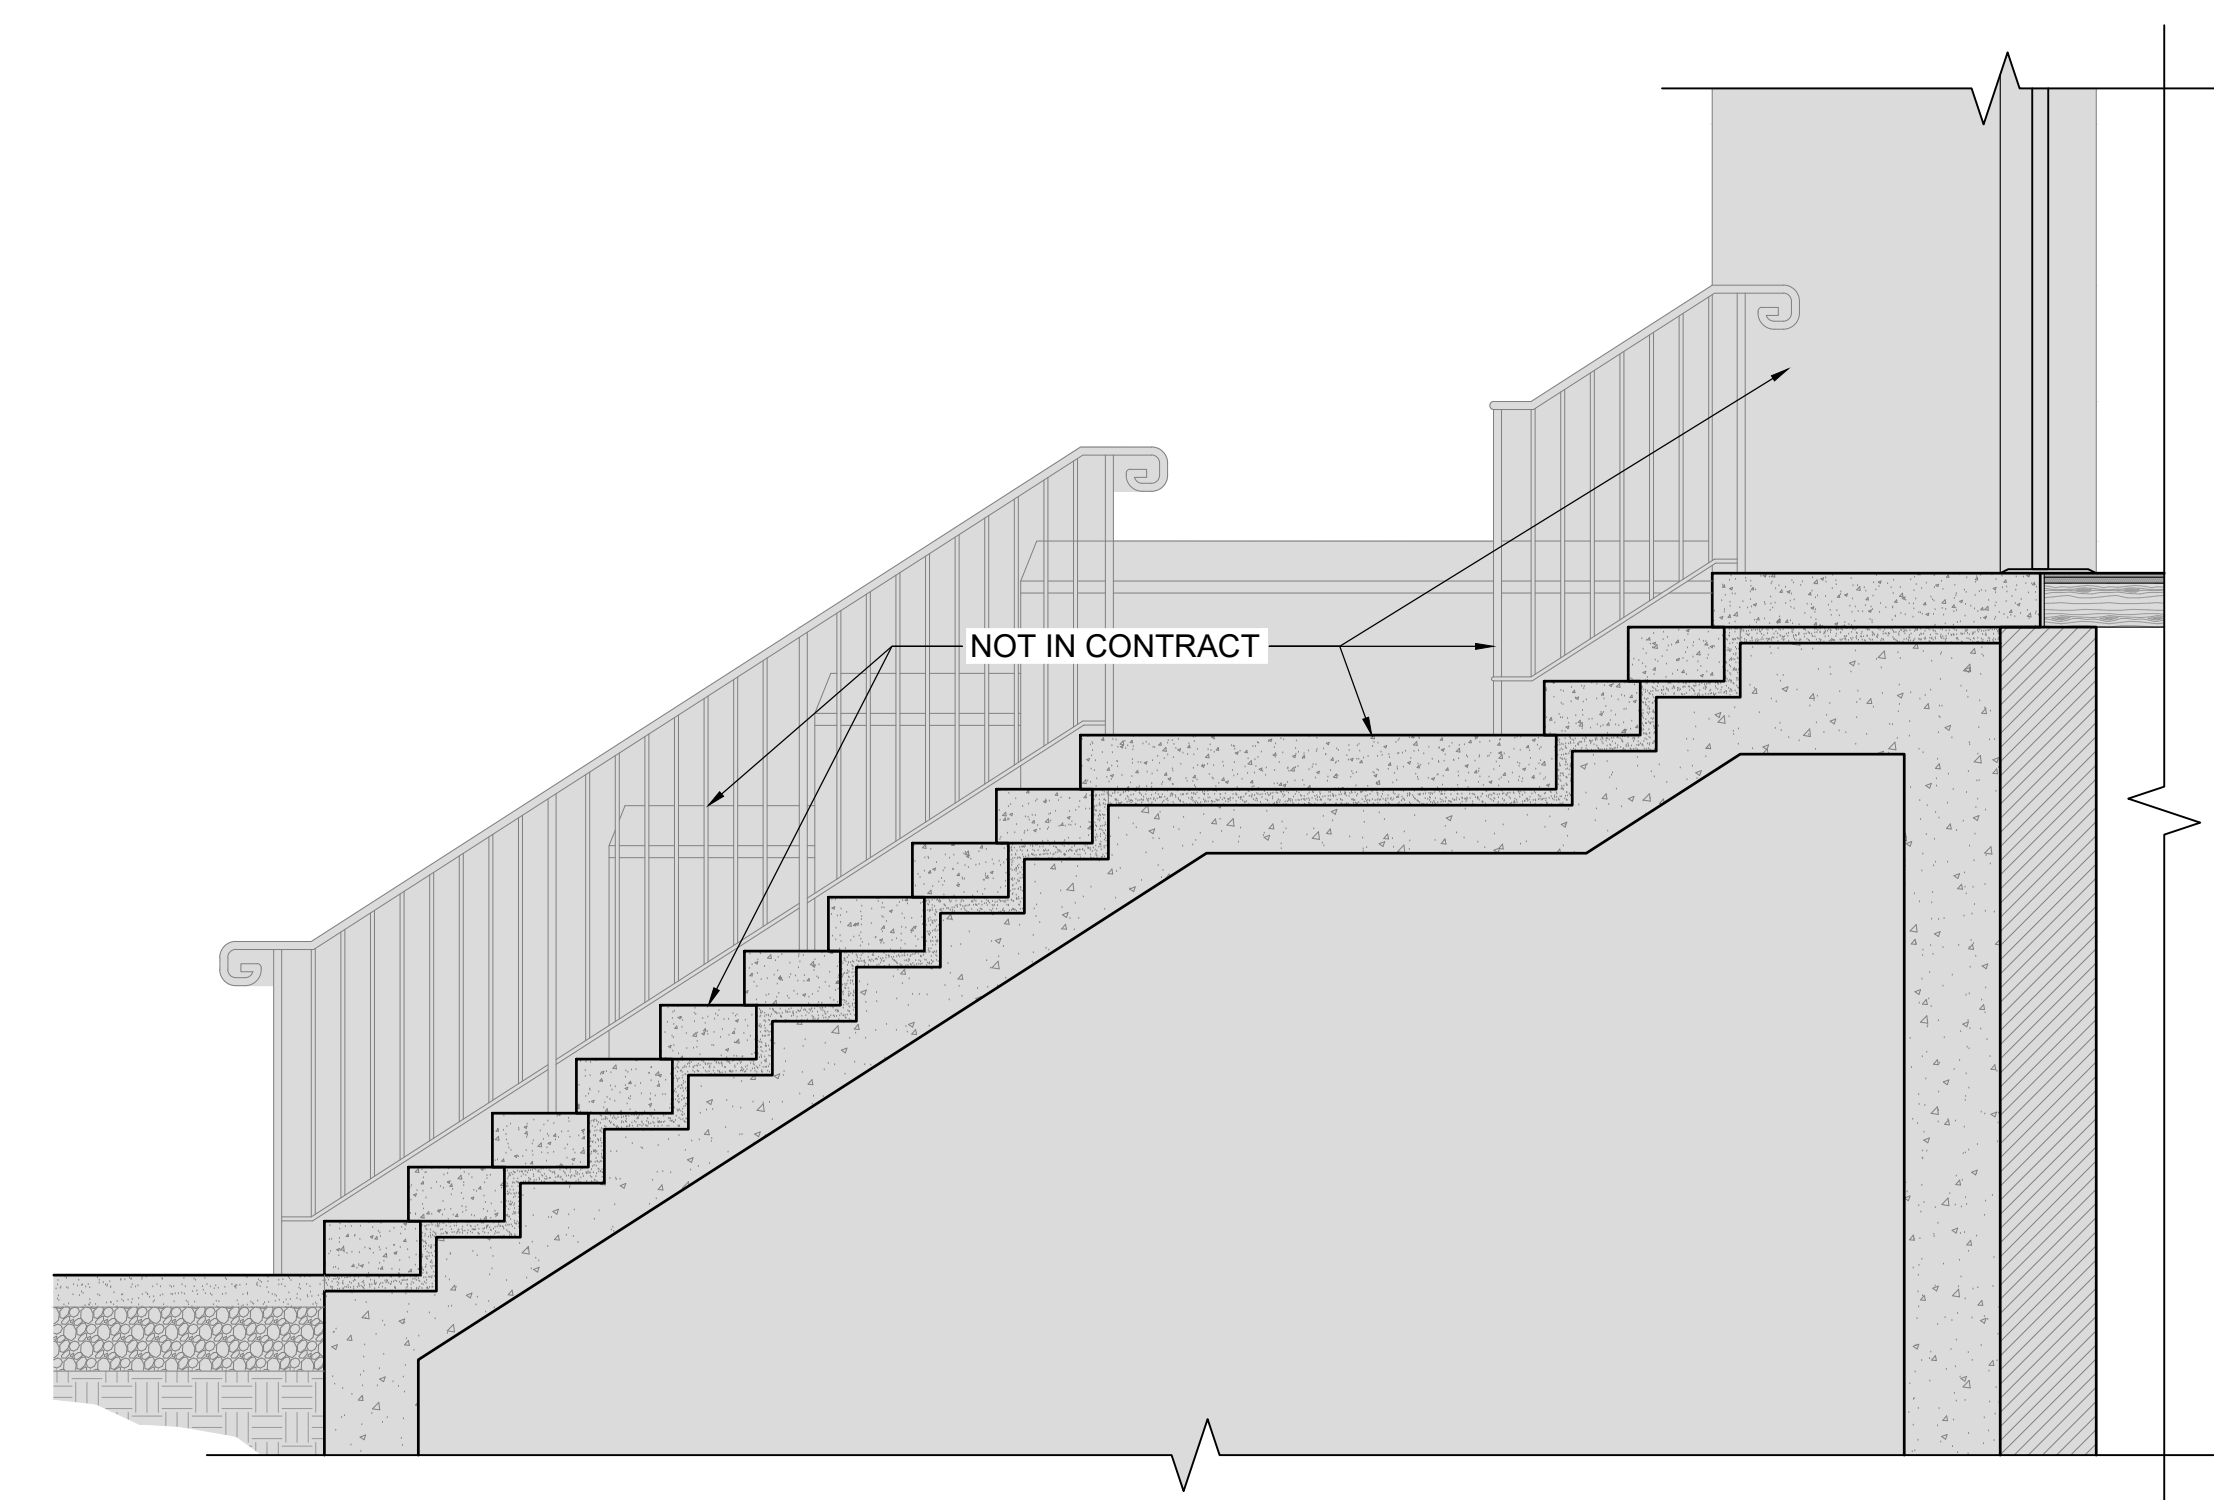
2 EXISTING EAST ENTRANCE STAIR SECTION - N. I. C.
1/2"=1'-0"
