ST. IGNATIUS CHURCH EXTERIOR RESTORATION PHASES 2 AND 3

28 COMMONWEALTH AVENUE, CHESTNUT HILL, MA 02467

ISSUED FOR PERMIT - 05/28/2026

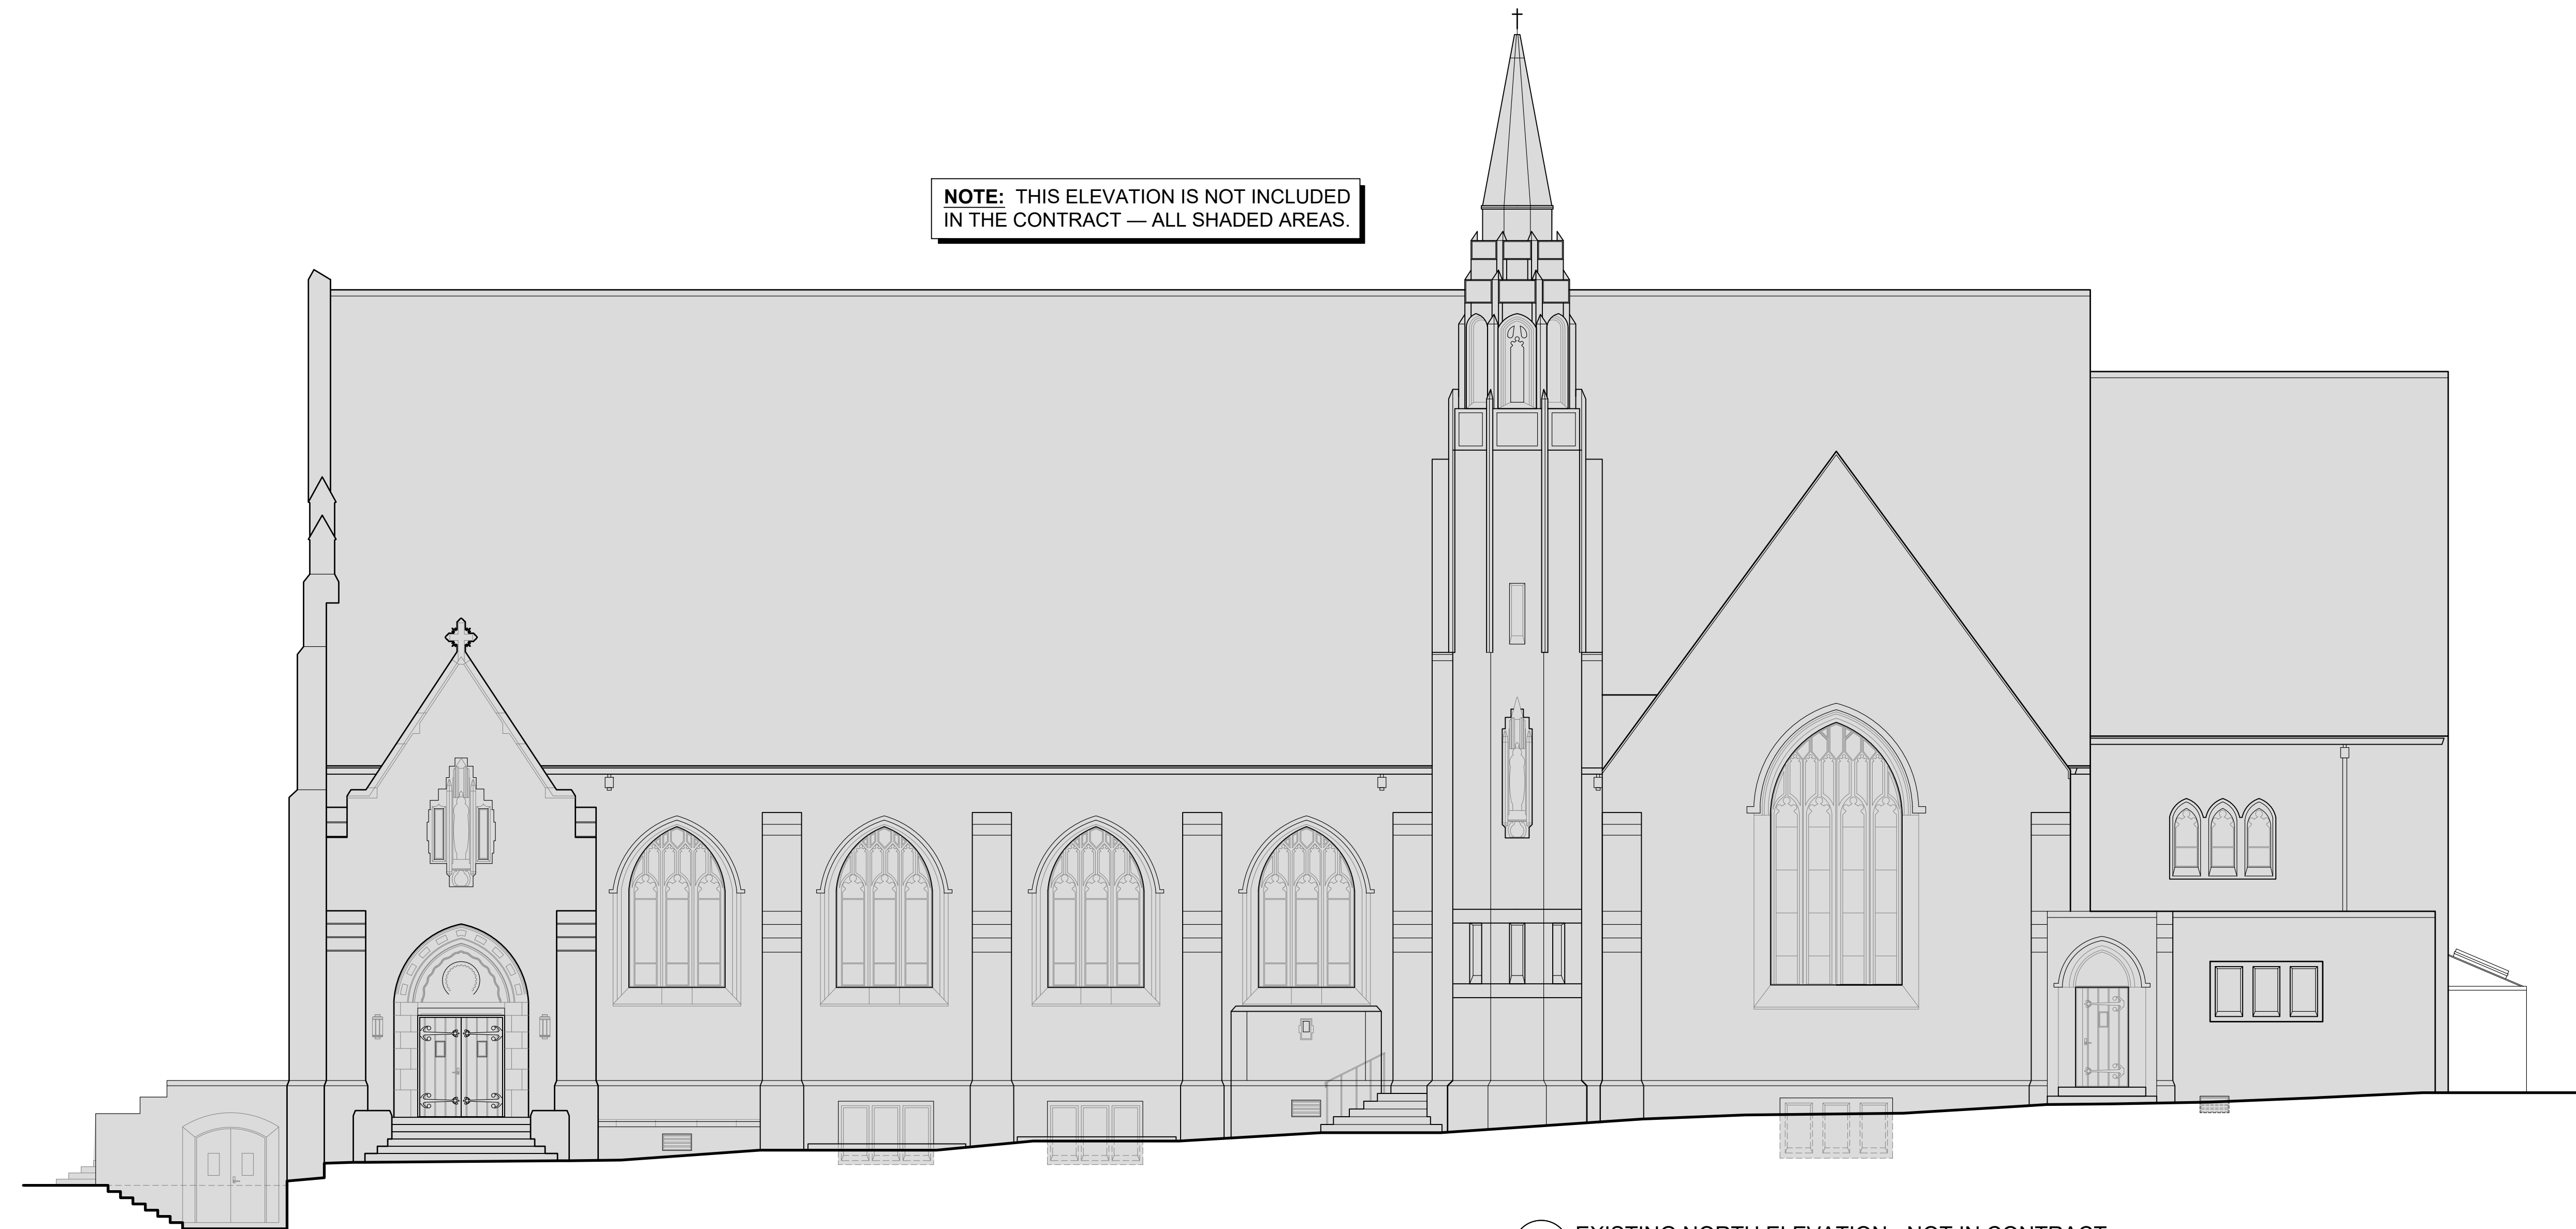
NOTE: THIS ELEVATION IS NOT INCLUDED IN THE CONTRACT — ALL SHADED AREAS.

1 EXISTING NORTH ELEVATION - NOT IN CONTRACT
1/8"=1'-0" 0 4'-0" 8'-0" 16'-0"

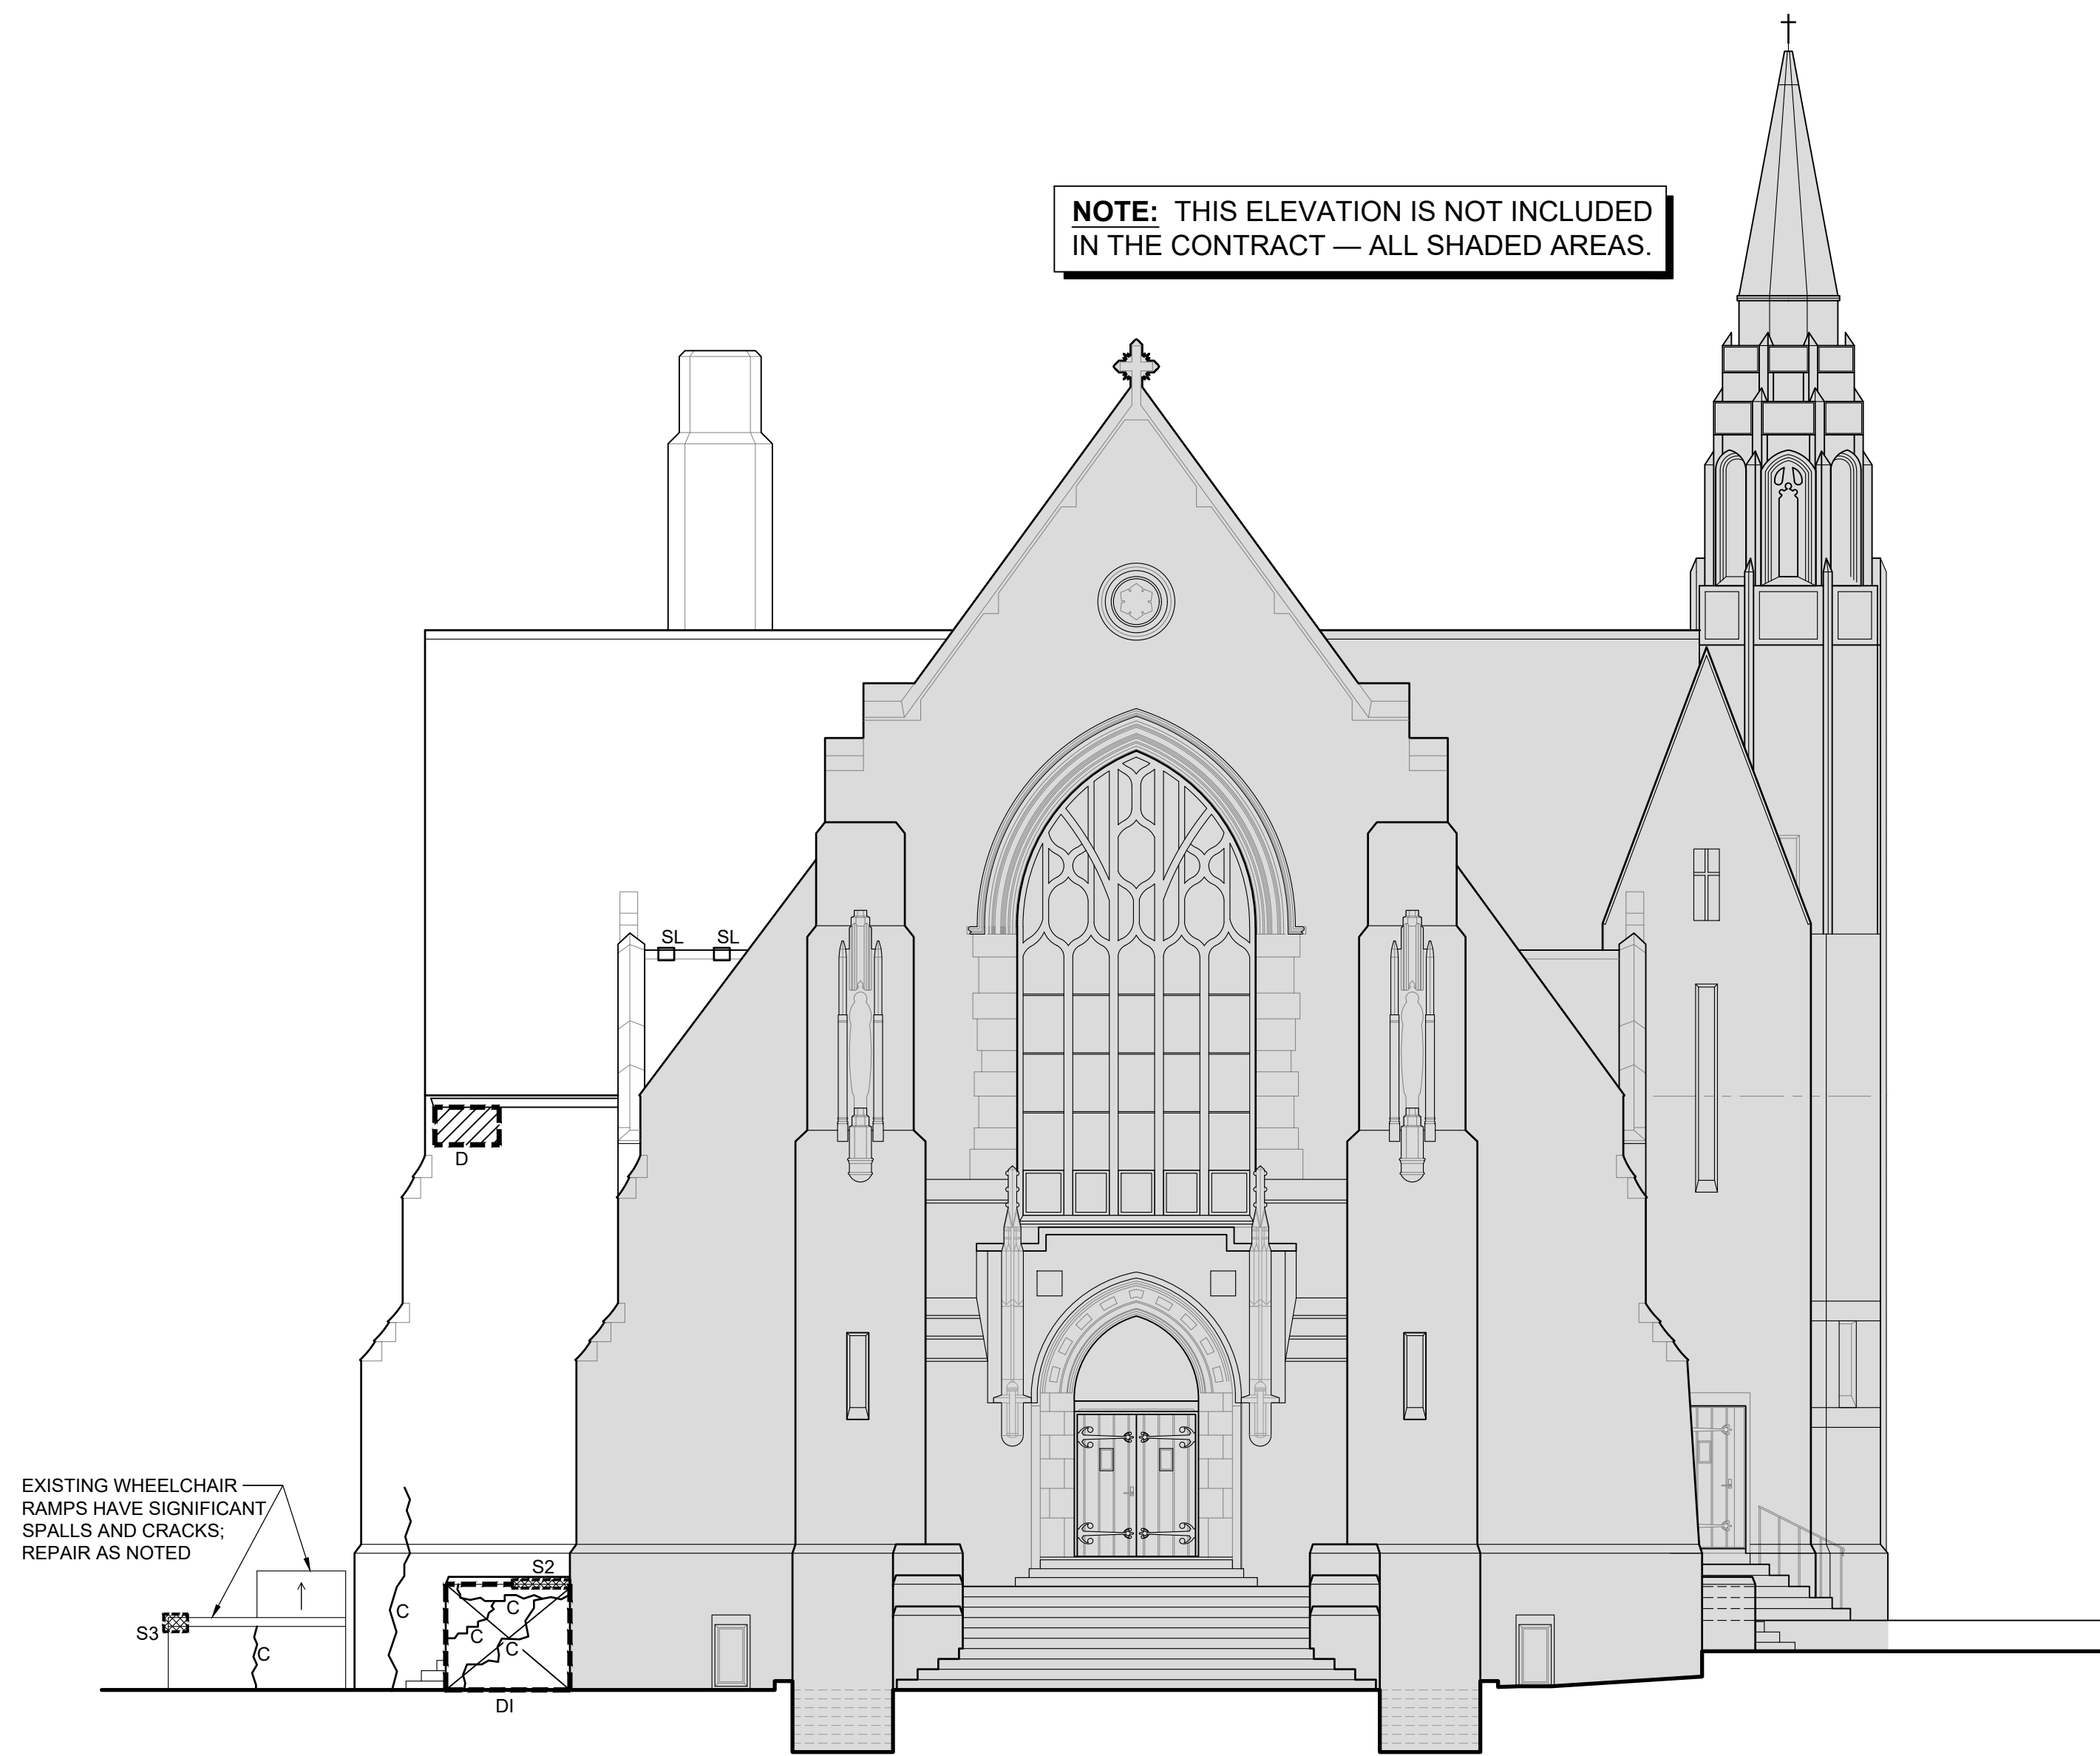
NOTE: THIS ELEVATION IS NOT INCLUDED IN THE CONTRACT — ALL SHADED AREAS.

2 EXISTING EAST ELEVATION
1/8"=1'-0"

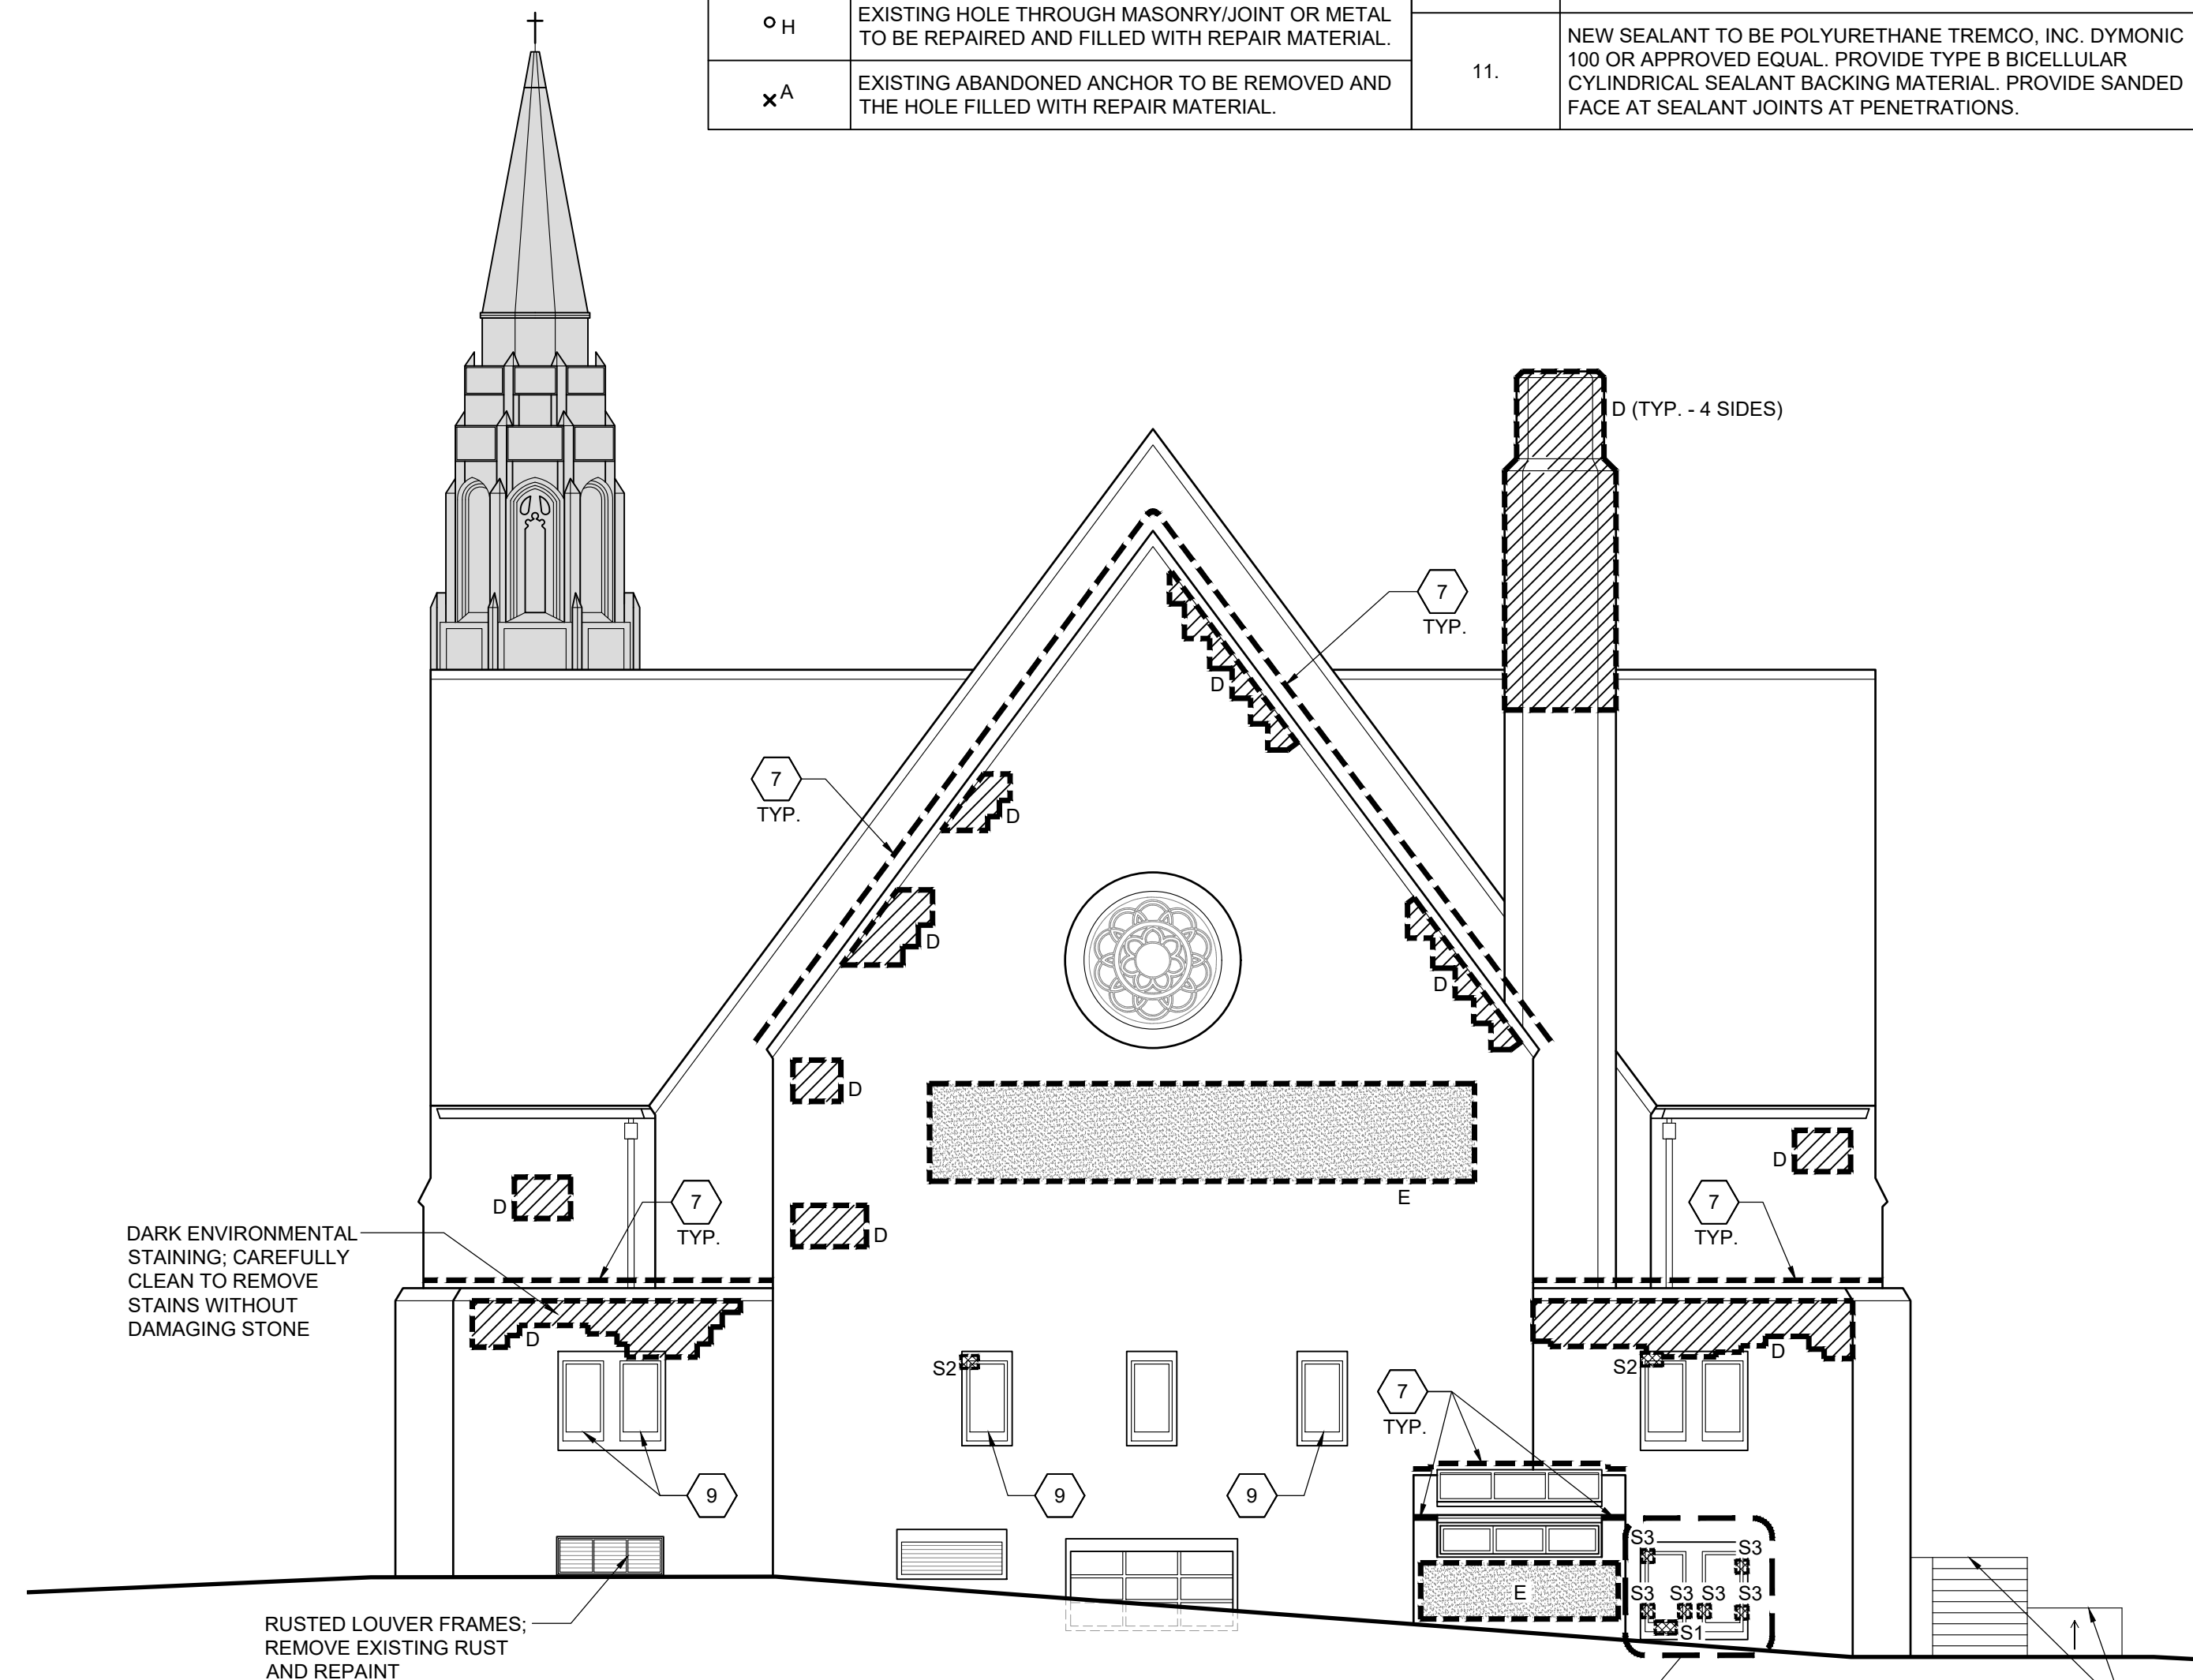
1 EXISTING WEST ELEVATION
1/8"=1'-0"

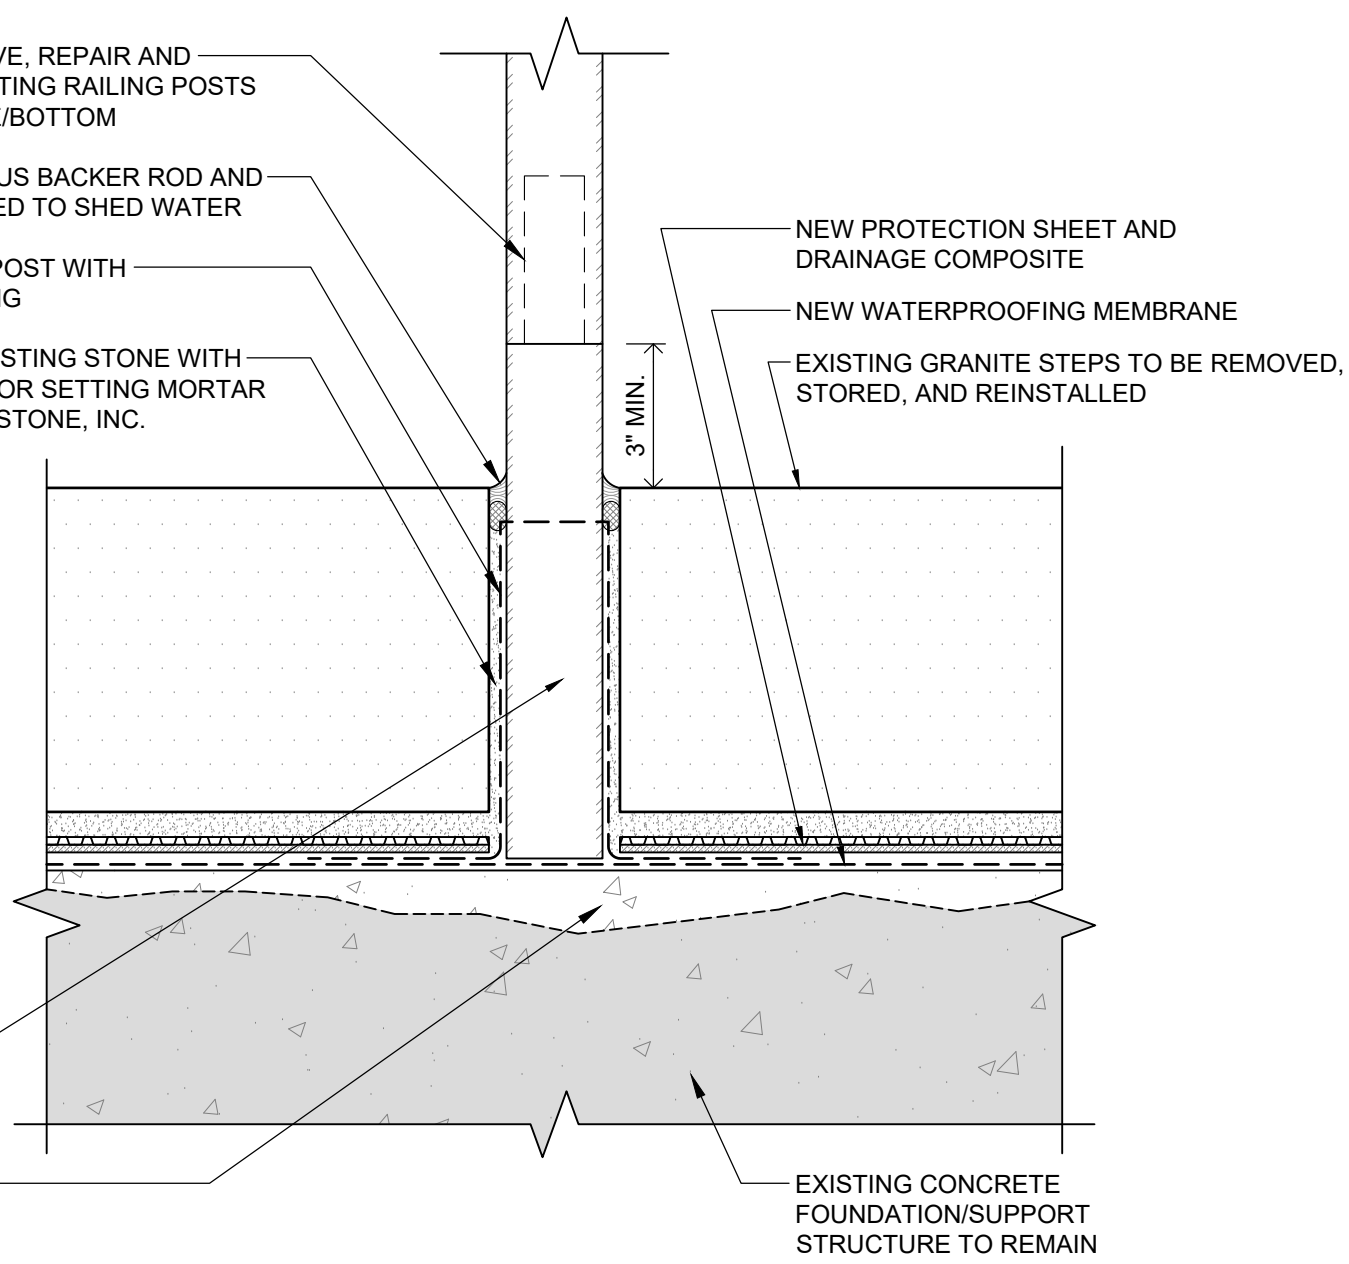
AT TUBE POSTS: NEW COLOR GALVANIZED POST BASES WITH SLEEVE TO REMOUNT EXISTING RAILINGS

4 TYPICAL RAILING POST FLASHING DETAIL
3"=1'-0"

2. MAINTAIN SAFE USE OF SIDEWALK AND ENTRANCES/EXITS THROUGHOUT RESTORATION.	EXISTING DETERIORATED/RUSTED ENTRANCE RAILING TO BE REMOVED, RESTORED, AND REINSTALLED. REFER TO DETAIL 4/A-501.	MEDIUM SPALL UP TO 2" DEPTH; CUT OUT LOOSE MATERIAL AND PREP VOID WITH SQUARE SHOULDERS. ADD S.S. PINS INTO SOUND BLOCK WITH S.S. WIRE MESH. INSTALL REPAIR MORTAR TO RESTORE MISSING MATERIAL. REPLICATE ORIGINAL SHAPE, SURFACE TEXTURE, AND APPEARANCE TO MATCH EXISTING. REFER TO DETAIL 4/A-502.	1. NEW MASONRY REBUILDING AND REPOINTING MORTAR TO BE JAHN M110 HISTORIC POINTING MORTAR, CUSTOM FORMULATED TO BE 20% WEAKER THAN EXISTING MASONRY MATERIALS AND REPAIR MORTARS.

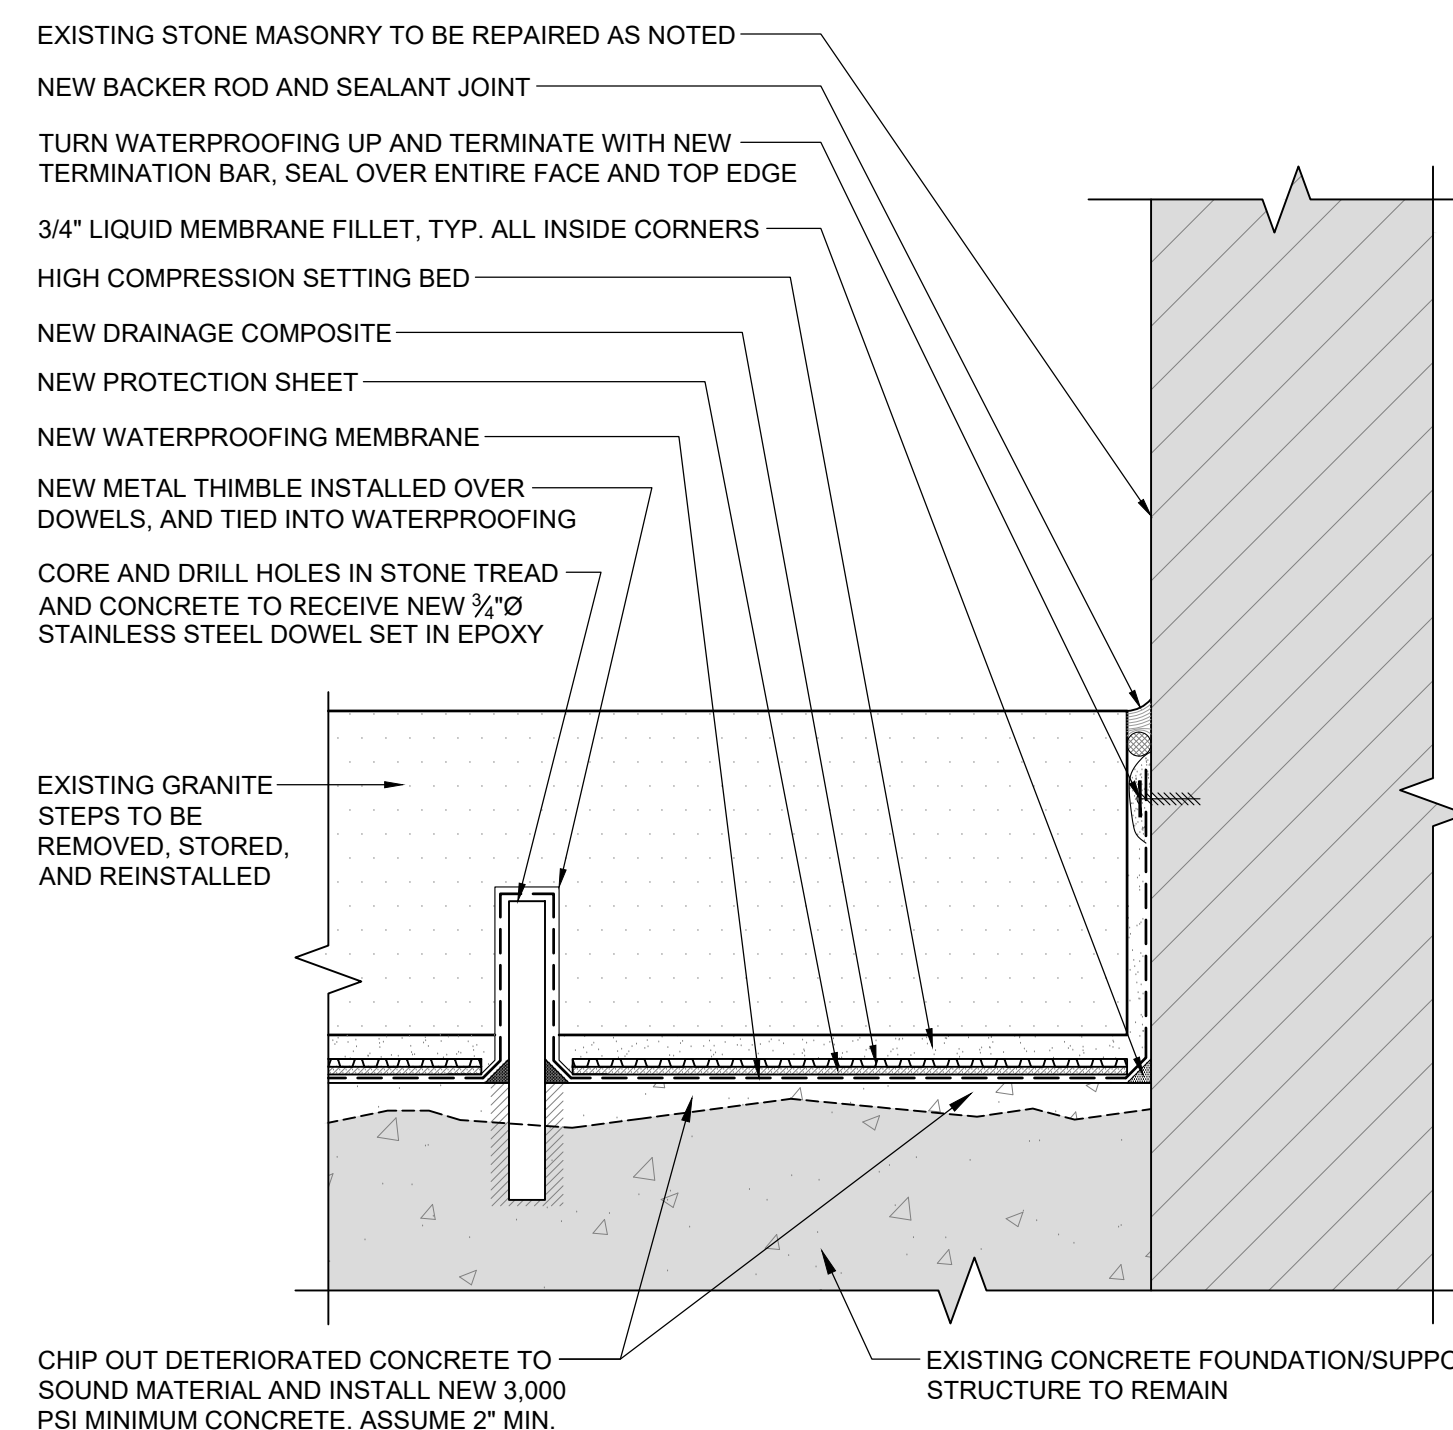
3 TYPICAL WATERPROOFING TERMINATION AT VERTICAL WALL
3"=1'-0"

NOTE: CLEAN AND PREP THE EXISTING CONCRETE FOUNDATION/SUPPORT STRUCTURE FOR THE NEW WATERPROOFING, INCLUDING SURFACE CONDITIONER AND "DECK PREP" LIQUID MEMBRANE.

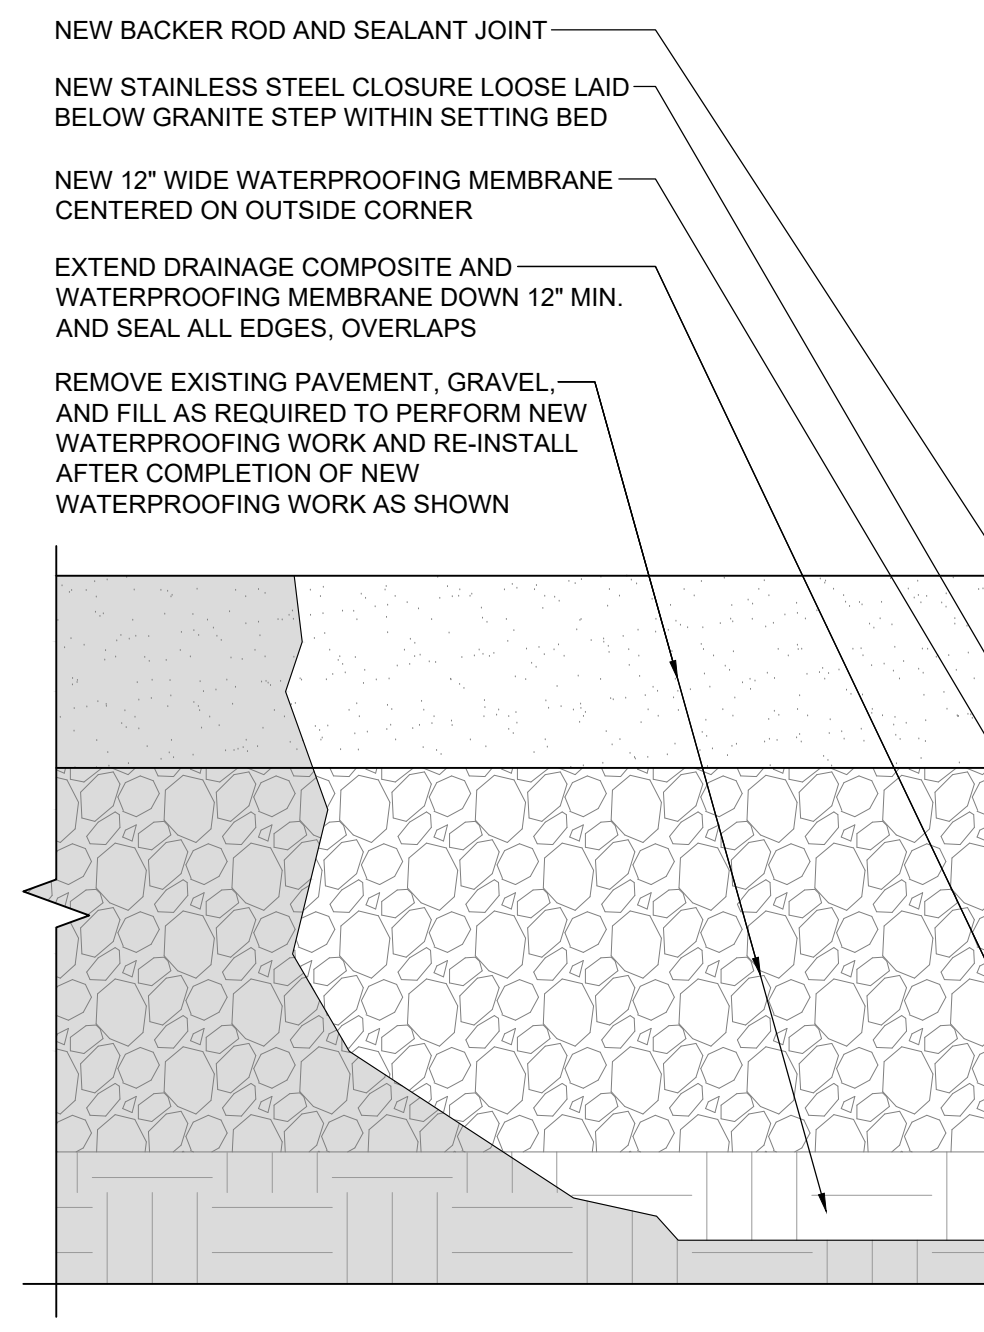
NOTE: DRILL NEW HOLES IN GRANITE STEPS TO RECEIVE NEW DOWELS, 2 PER STONE.

2 NEW STAIR SECTION AT PAVEMENT
3"=1'-0"

NOTE: CLEAN AND PREP THE EXISTING CONCRETE FOUNDATION/SUPPORT STRUCTURE FOR THE NEW WATERPROOFING, INCLUDING SURFACE CONDITIONER AND "DECK PREP" LIQUID MEMBRANE.

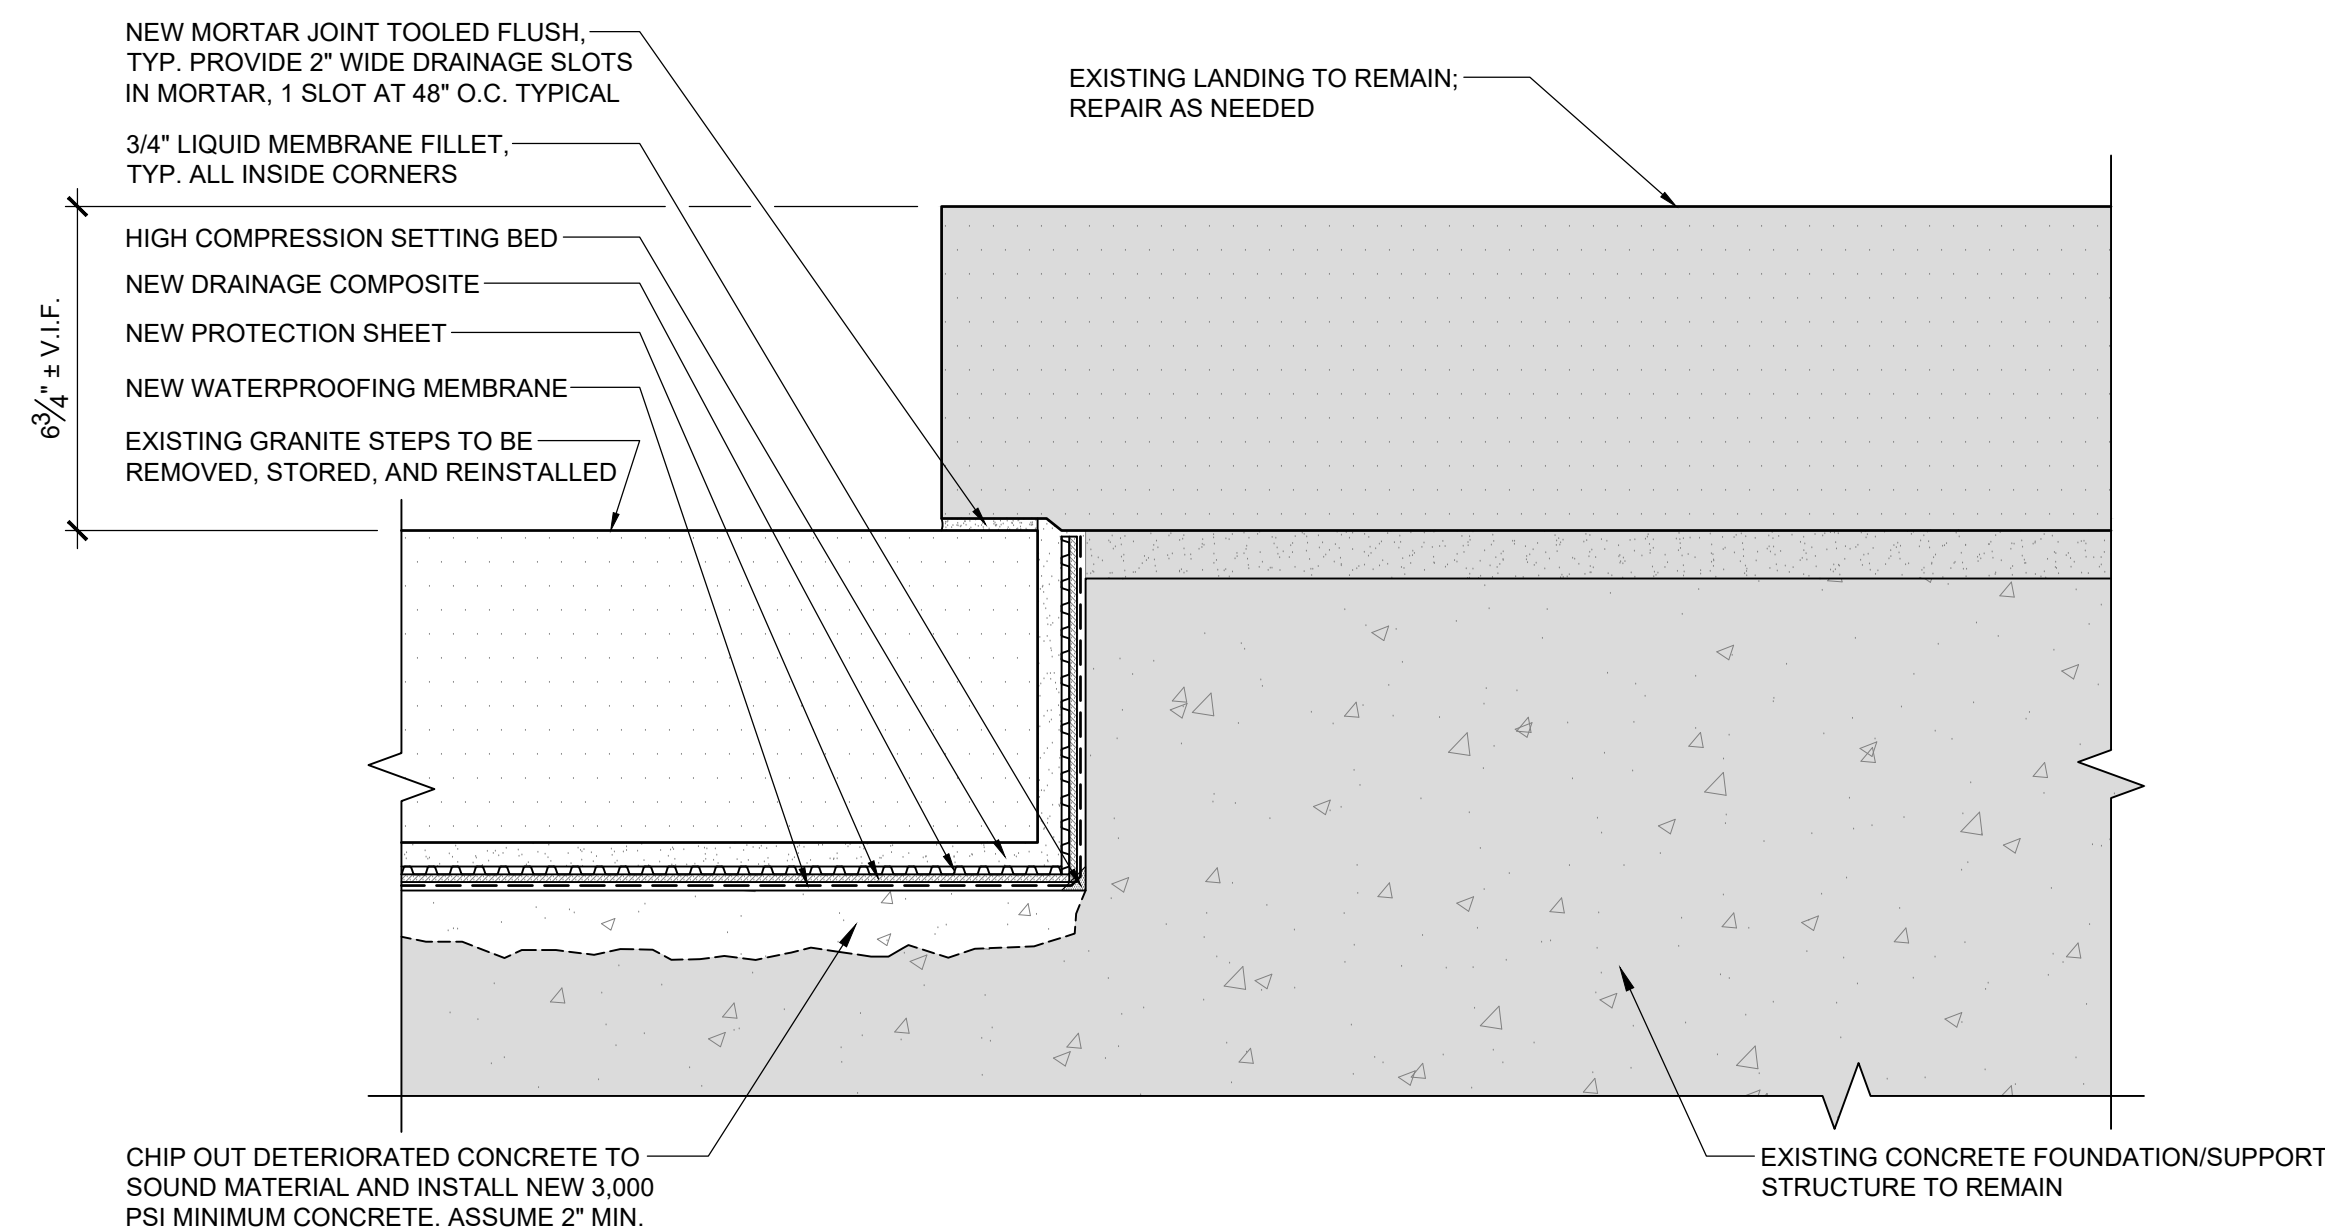
1 NEW STAIR/LANDING SECTION AT DOOR
3"=1'-0"

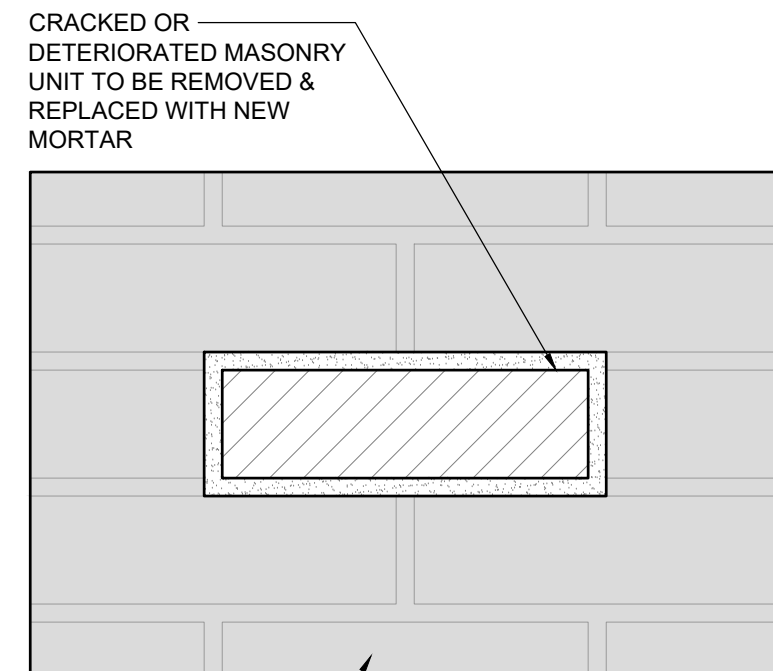
1. BRICK AND MORTAR REPLACEMENT - ELEVATION VIEW

NOTE: DO NOT DAMAGE EXISTING ADJACENT MASONRY TO REMAIN.

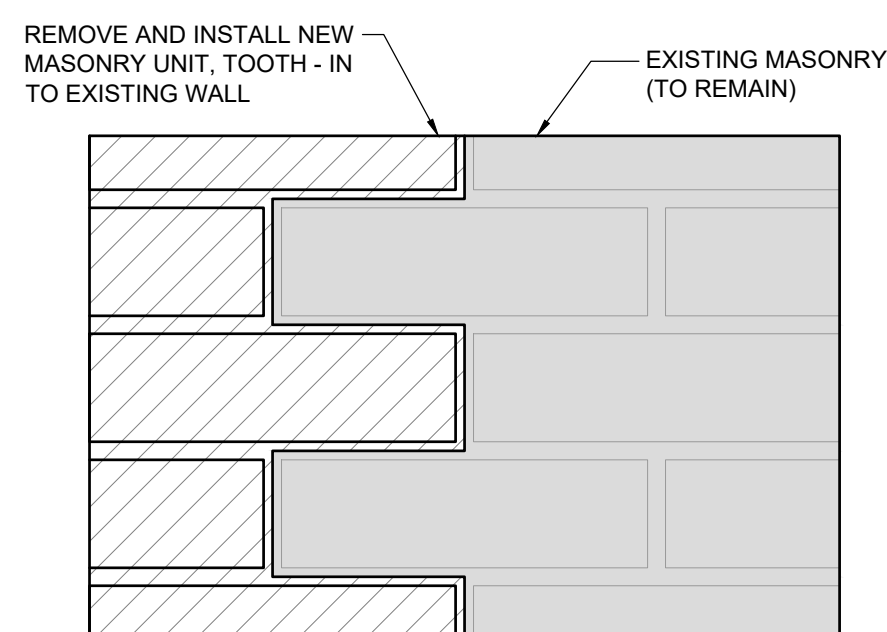
NOTE: DO NOT DAMAGE EXISTING ADJACENT MASONRY TO REMAIN.

7 MASONRY TOOTH-IN DETAIL

3. CONTRACTOR TO MAINTAIN ALL NECESSARY PERMITS THROUGHOUT RESTORATION.	REMOVE EXISTING RUST STAINING FROM THE SURFACE OF EXISTING STONE STEPS AND LANDING.	CRITICAL SPALL; PIECE BEYOND REPAIR. REMOVE AND REPLACE WITH NEW MASONRY UNIT. TOOTH-IN TO EXISTING WALL. REPLICATE ORIGINAL SHAPE, SURFACE TEXTURE, AND APPEARANCE TO MATCH EXISTING. REFER TO DETAIL 7&8/A-502.

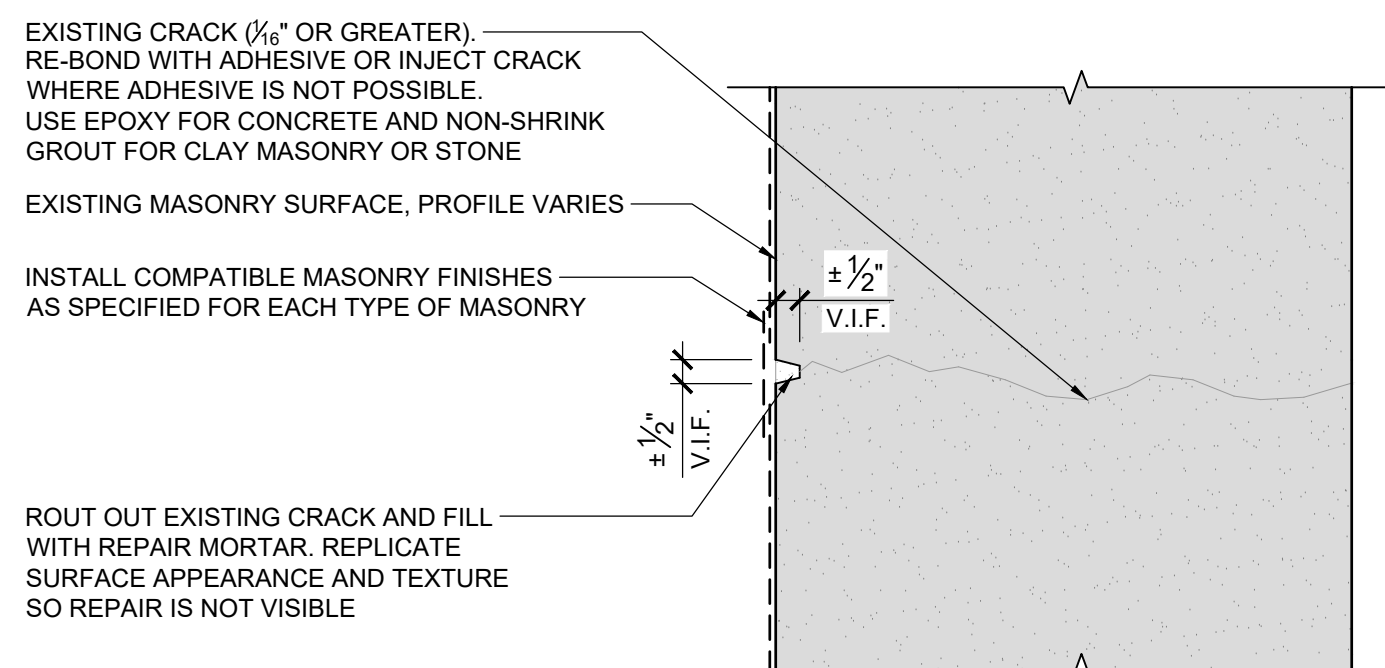
NOTE: NEW AREA OF MASONRY REPAIR SHALL MATCH EXISTING ADJACENT MASONRY IN PROFILE, TEXTURE AND FINISH.

6 MASONRY CRACK REPAIR - REPAIR MORTAR

8. AT CONTRACTOR'S OPTION, DAMAGED LIMESTONE PIECES CAN BE REPLACED IN-KIND INSTEAD OF REPAIRED.	REPAIR DAMAGED STONE WINDOW SURROUND ON THE INTERIOR OF THIS WINDOW.	EXISTING CRACK THROUGH MASONRY; ROUT AND REPAIR WITH ADHESIVE AND REPAIR MORTAR. REFER TO DETAIL 6/A-502.	
		EXISTING HOLE THROUGH MASONRY JOINT OR METAL TO BE REPAIRED AND FILLED WITH REPAIR MATERIAL.	
		EXISTING ABANDONED ANCHOR TO BE REMOVED AND THE HOLE FILLED WITH REPAIR MATERIAL.

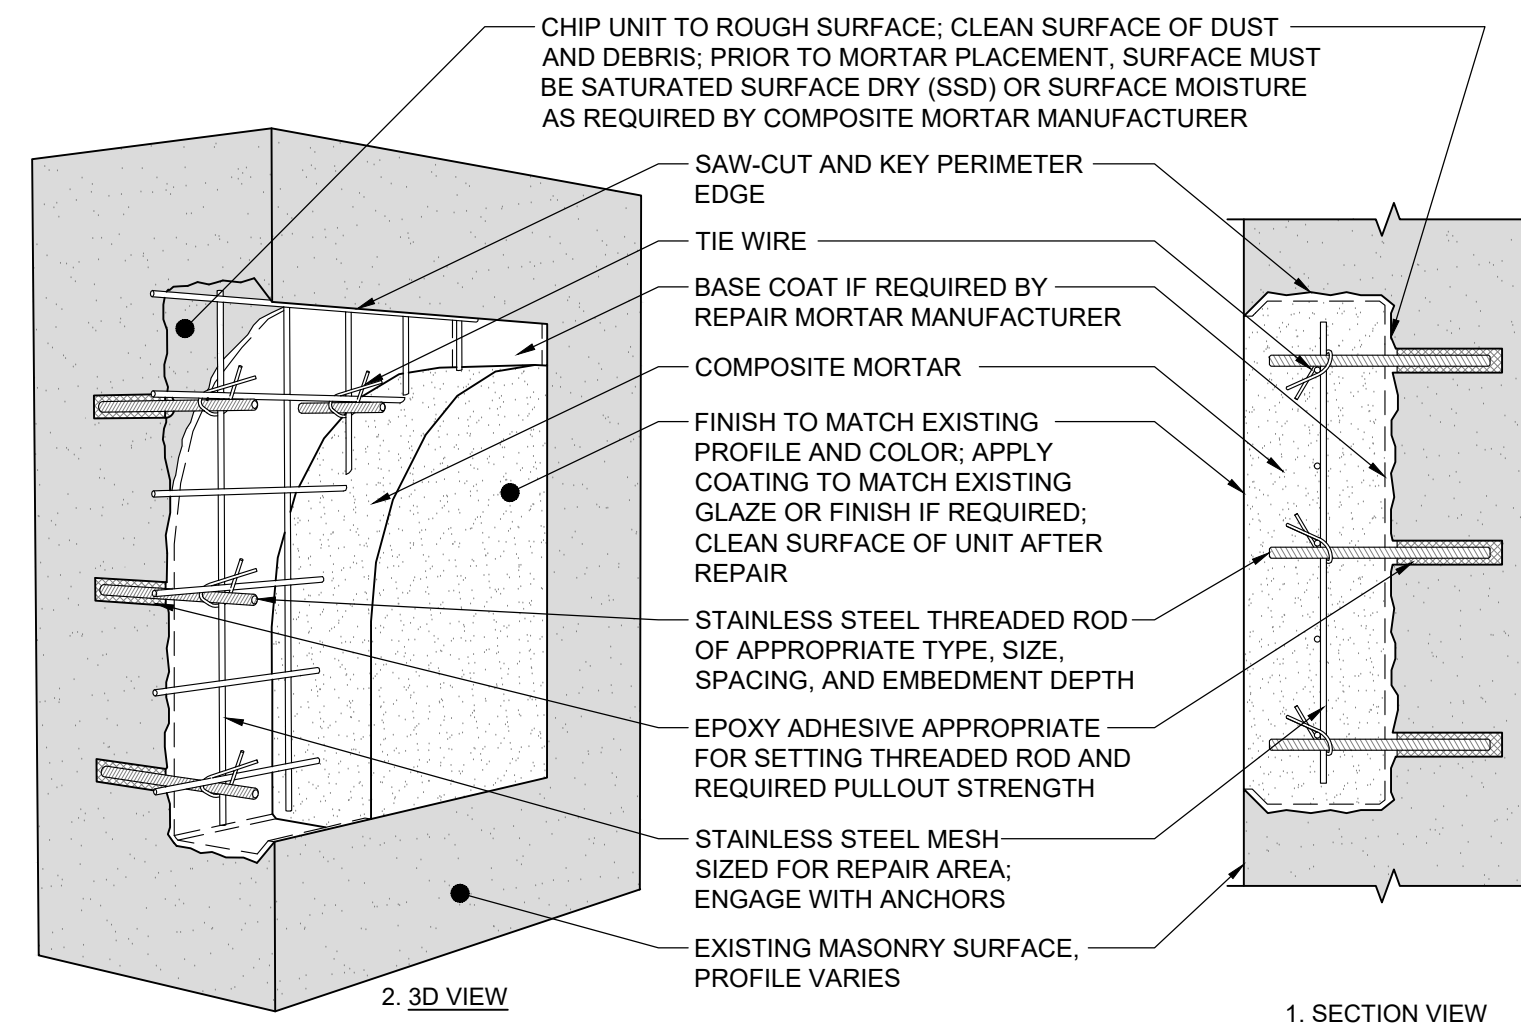
NOTE: CONTRACTOR TO ALLOW ARCHITECT TO SOUND COMPLETED SPALL REPAIR AREAS TO CONFIRM THAT PATCHES ARE WELL-BONDED TO PARENT STONE.

5 MASONRY SPALL REPAIR - LARGE (GREATER THAN 2" DEPTH)

2. MAINTAIN SAFE USE OF SIDEWALK AND ENTRANCES/EXITS THROUGHOUT RESTORATION.	CAREFULLY LABEL AND REMOVE EXISTING LIMESTONE CAP STONES. REPAIR SPALLS AND CRACKS AS NOTED. INSTALL NEW THROUGH-WALL FLASHING AND REINSTALL CAP STONES WITH BACKER ROD AND SEALANT AT HEAD JOINTS. REFER TO DETAILS 1&2/A-502, 3/A-101, AND 3/A-102.	LARGE (LOOSE) SPALL GREATER THAN 2" DEPTH; LARGE SECTION OF LOOSE MATERIAL. CAREFULLY REMOVE LOOSE MATERIAL AND REINSTALL LOOSE PIECE BACK TO PARENT STONE WITH ADHESIVE AND S.S. PINS INTO SOUND BLOCK WITH S.S. WIRE MESH. INSTALL REPAIR MORTAR TO RESTORE MISSING MATERIAL. REPLICATE ORIGINAL SHAPE, SURFACE TEXTURE, AND APPEARANCE TO MATCH EXISTING. REFER TO DETAIL 5/A-502.
