ST. IGNATIUS CHURCH EXTERIOR RESTORATION PHASES 2 AND 3

28 COMMONWEALTH AVENUE, CHESTNUT HILL, MA 02467

ISSUED FOR PERMIT - 05/28/2026

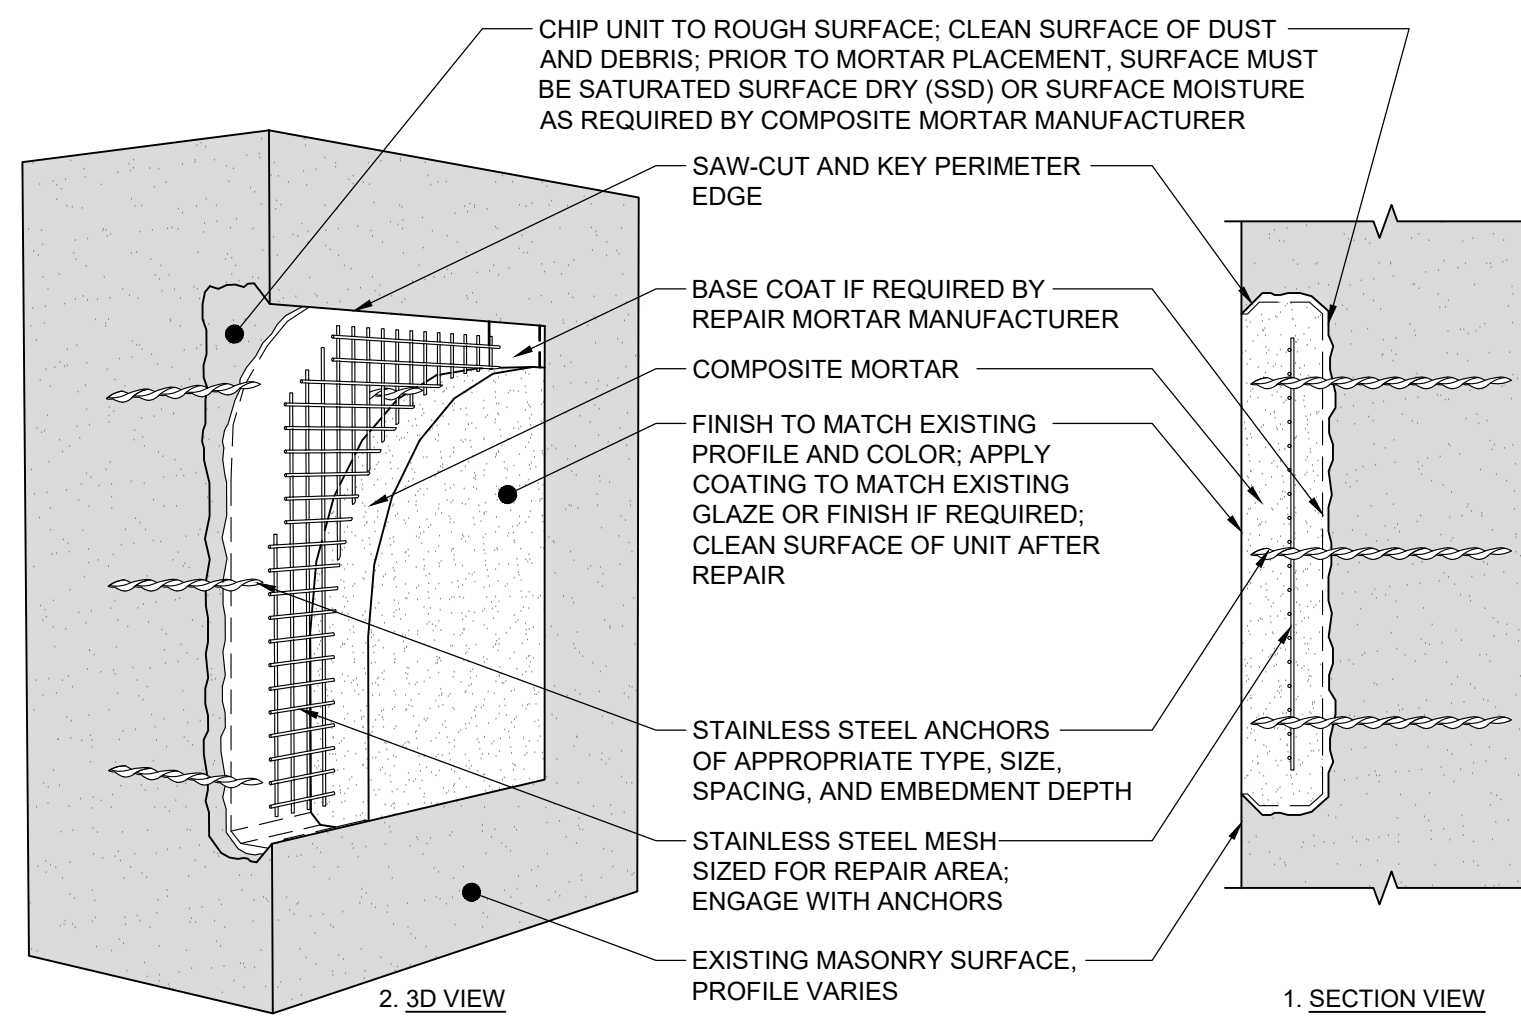
NOTE: CONTRACTOR TO ALLOW ARCHITECT TO SOUND COMPLETED SPALL REPAIR AREAS TO CONFIRM THAT PATCHES ARE WELL-BONDED TO PARENT STONE.

4 MASONRY SPALL REPAIR - MEDIUM (UP TO 2" DEPTH)

4. ALL MATERIALS TO BE APPROVED PRIOR TO USE THROUGH ON-SITE MOCKUPS.	ADHERE CRACKED PIECE TO PARENT STONE WITH ADHESIVE AND STAINLESS STEEL PINS PRIOR TO REINSTALLATION. REFER TO DETAIL 4/A-503.	EXISTING DE-BONDED MASONRY OR LIMESTONE UNIT TO BE REINFORCED IN PLACE. REFER TO DETAIL 3/A-503.

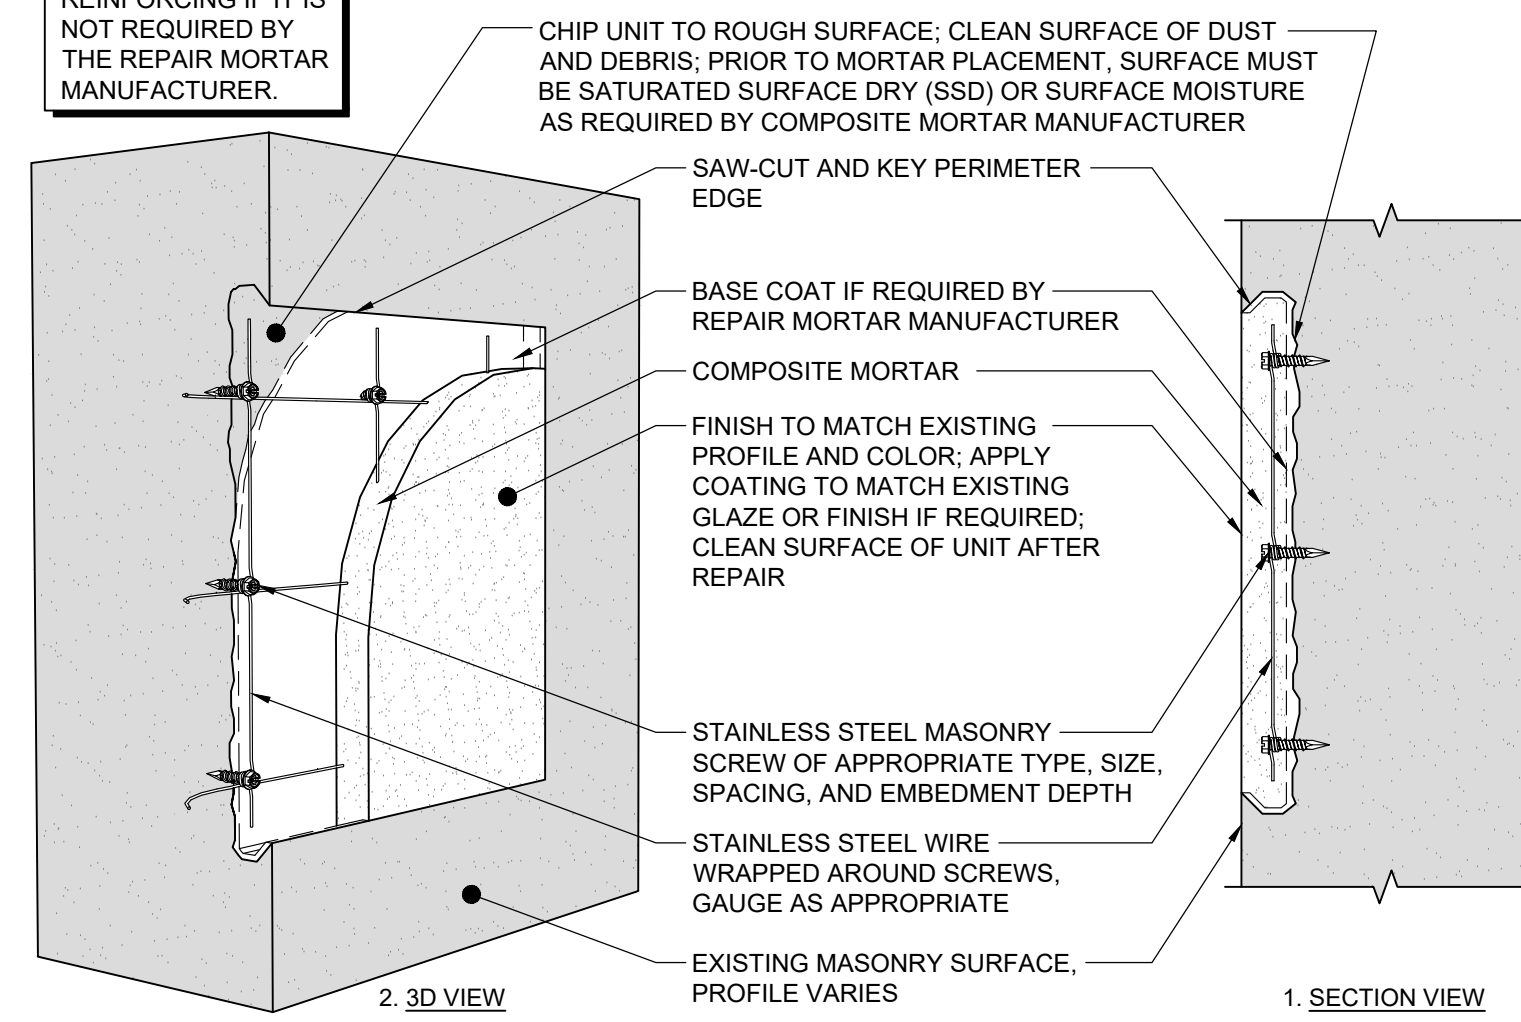
NOTE: CONTRACTOR CAN NOT INSTALL REINFORCING IF IT IS NOT REQUIRED BY THE REPAIR MORTAR MANUFACTURER.

NOTE: CONTRACTOR TO ALLOW ARCHITECT TO SOUND COMPLETED SPALL REPAIR AREAS TO CONFIRM THAT PATCHES ARE WELL-BONDED TO PARENT STONE.

3 MASONRY SPALL REPAIR - SMALL (1" TO 1.5" DEPTH)

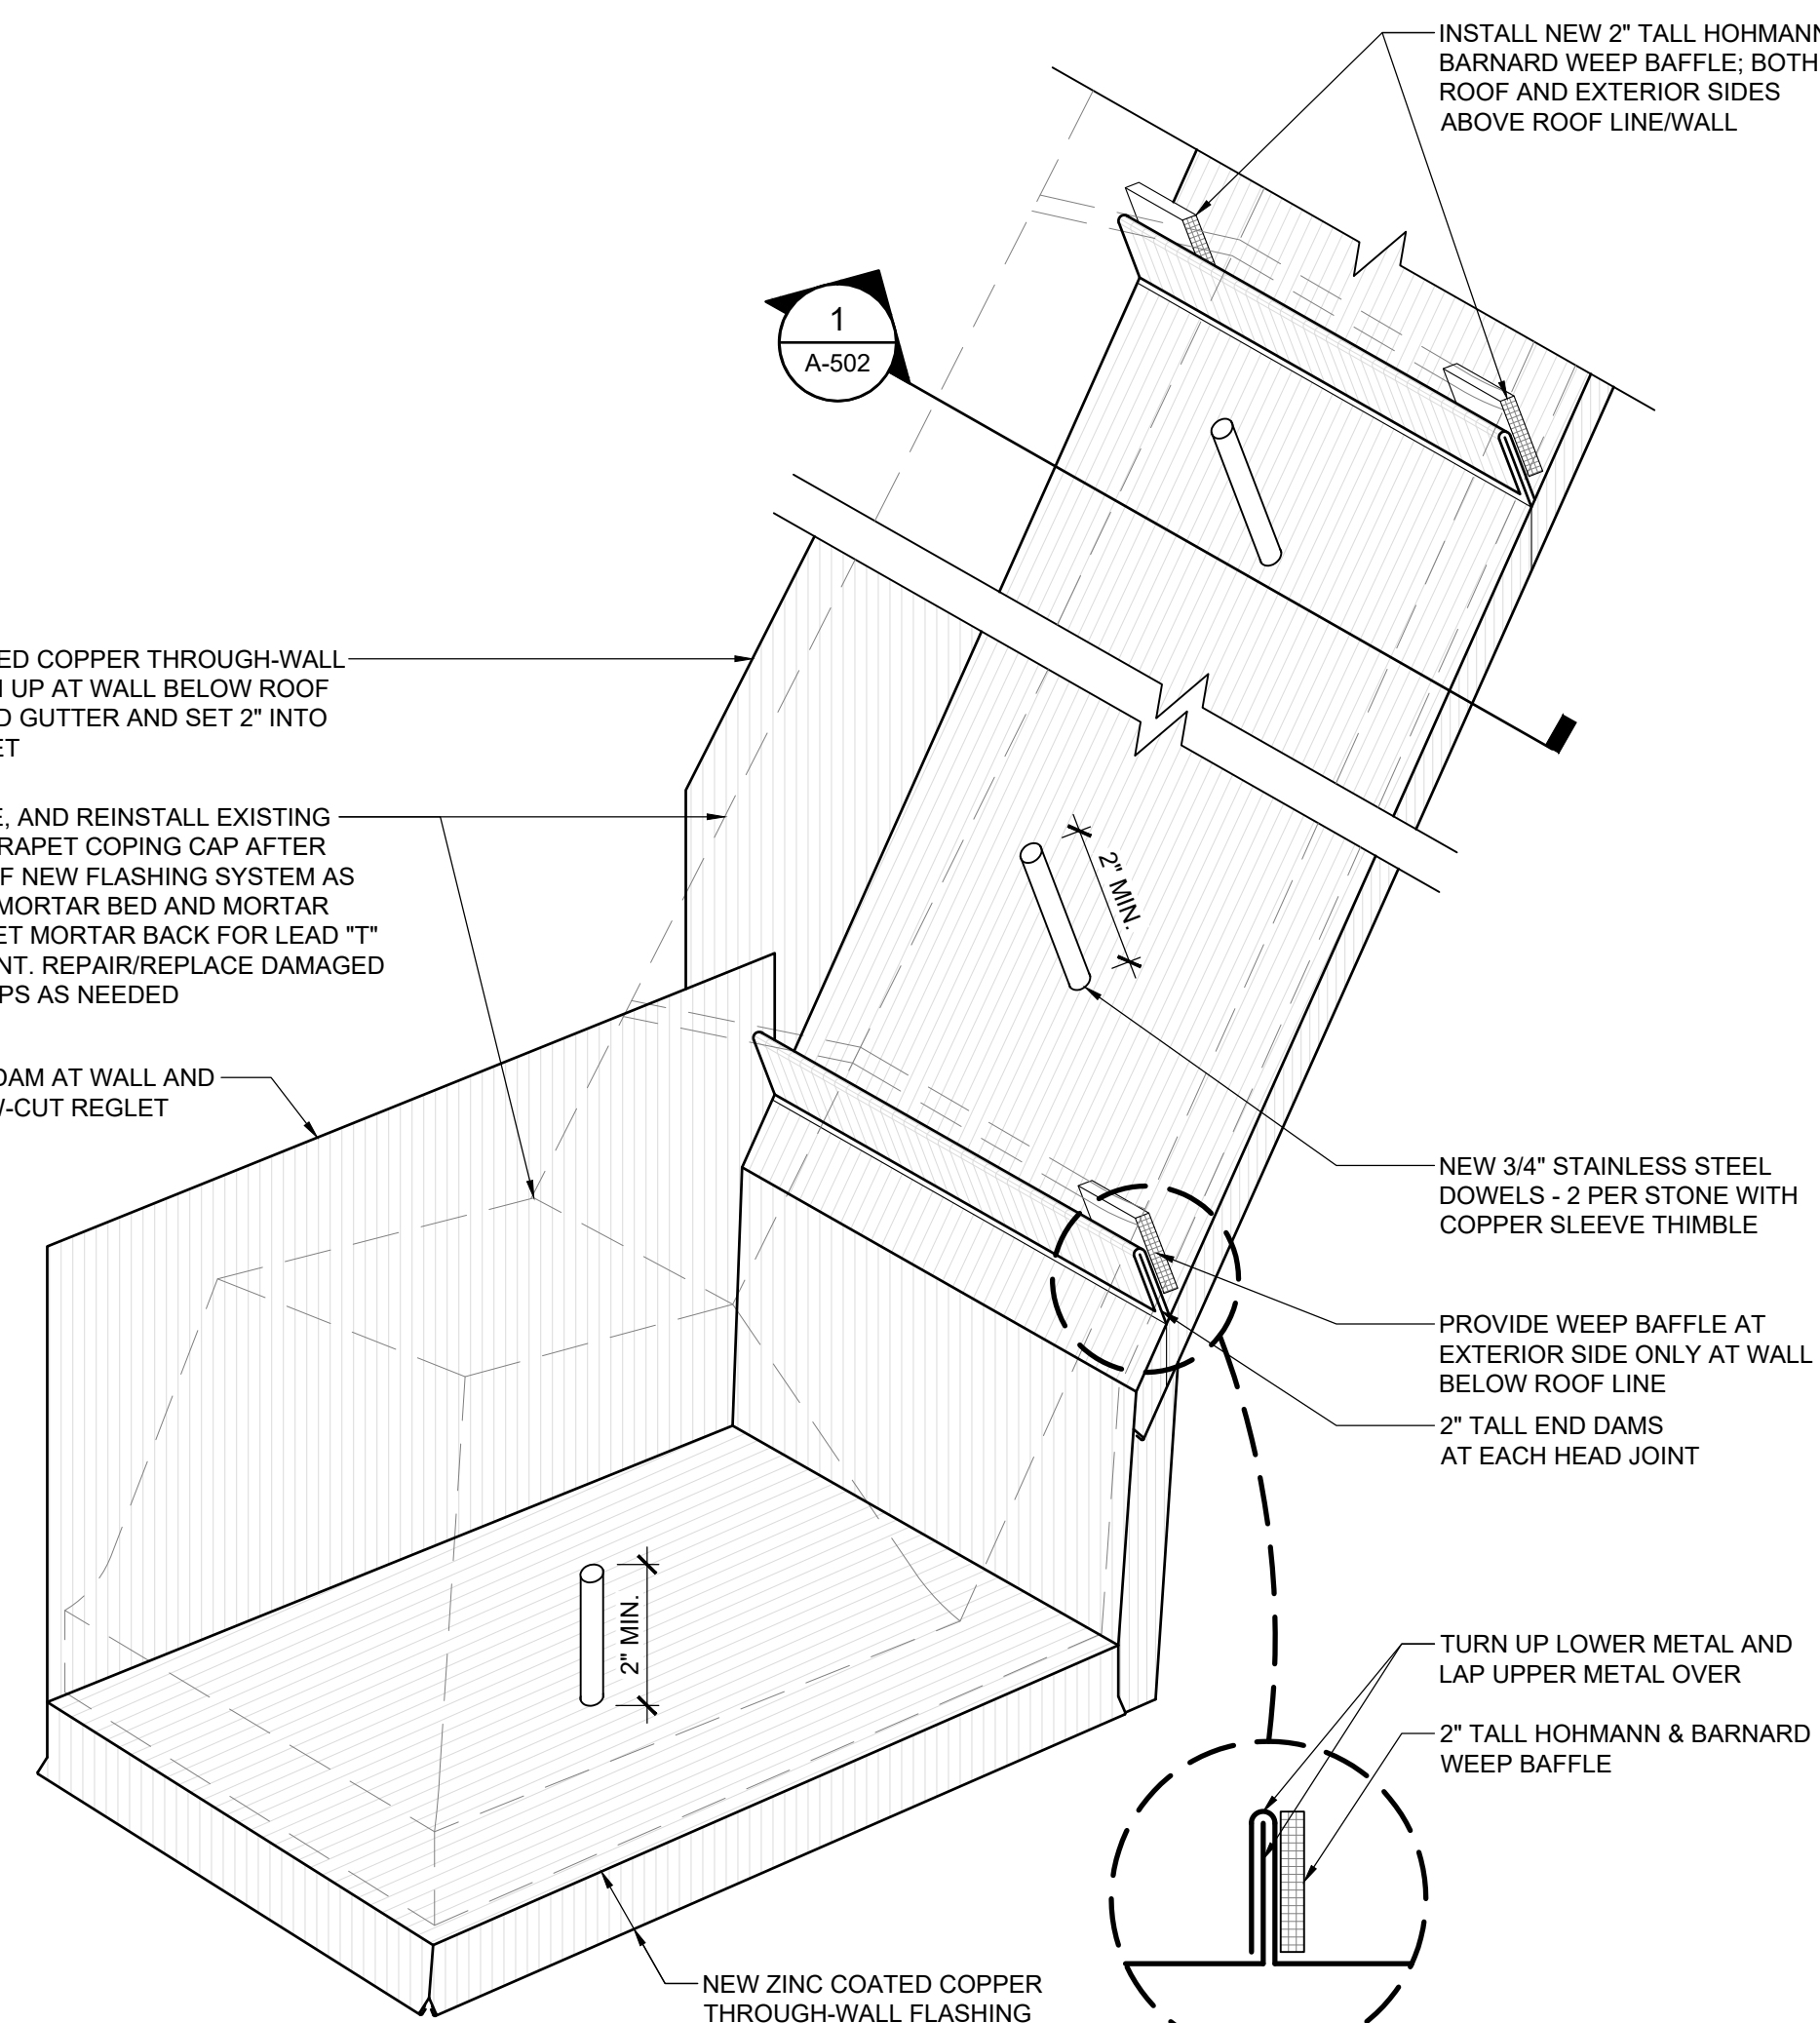
REMOVE, STORE, AND REINSTALL EXISTING CAST STONE PARAPET COPING CAP AFTER INSTALLATION OF NEW FLASHING SYSTEM AS SHOWN. SET IN MORTAR BED AND MORTAR HEAD JOINTS. SET MORTAR BACK FOR LEAD "T" CAP AND SEALANT. REPAIR/REPLACE DAMAGED CAST STONE CAPS AS NEEDED

TURN UP BACK DAM AT WALL AND SET 2" INTO SAW-CUT REGLET

2 NEW PARAPET CAPSTONE FLASHING DETAIL - ISOMETRIC

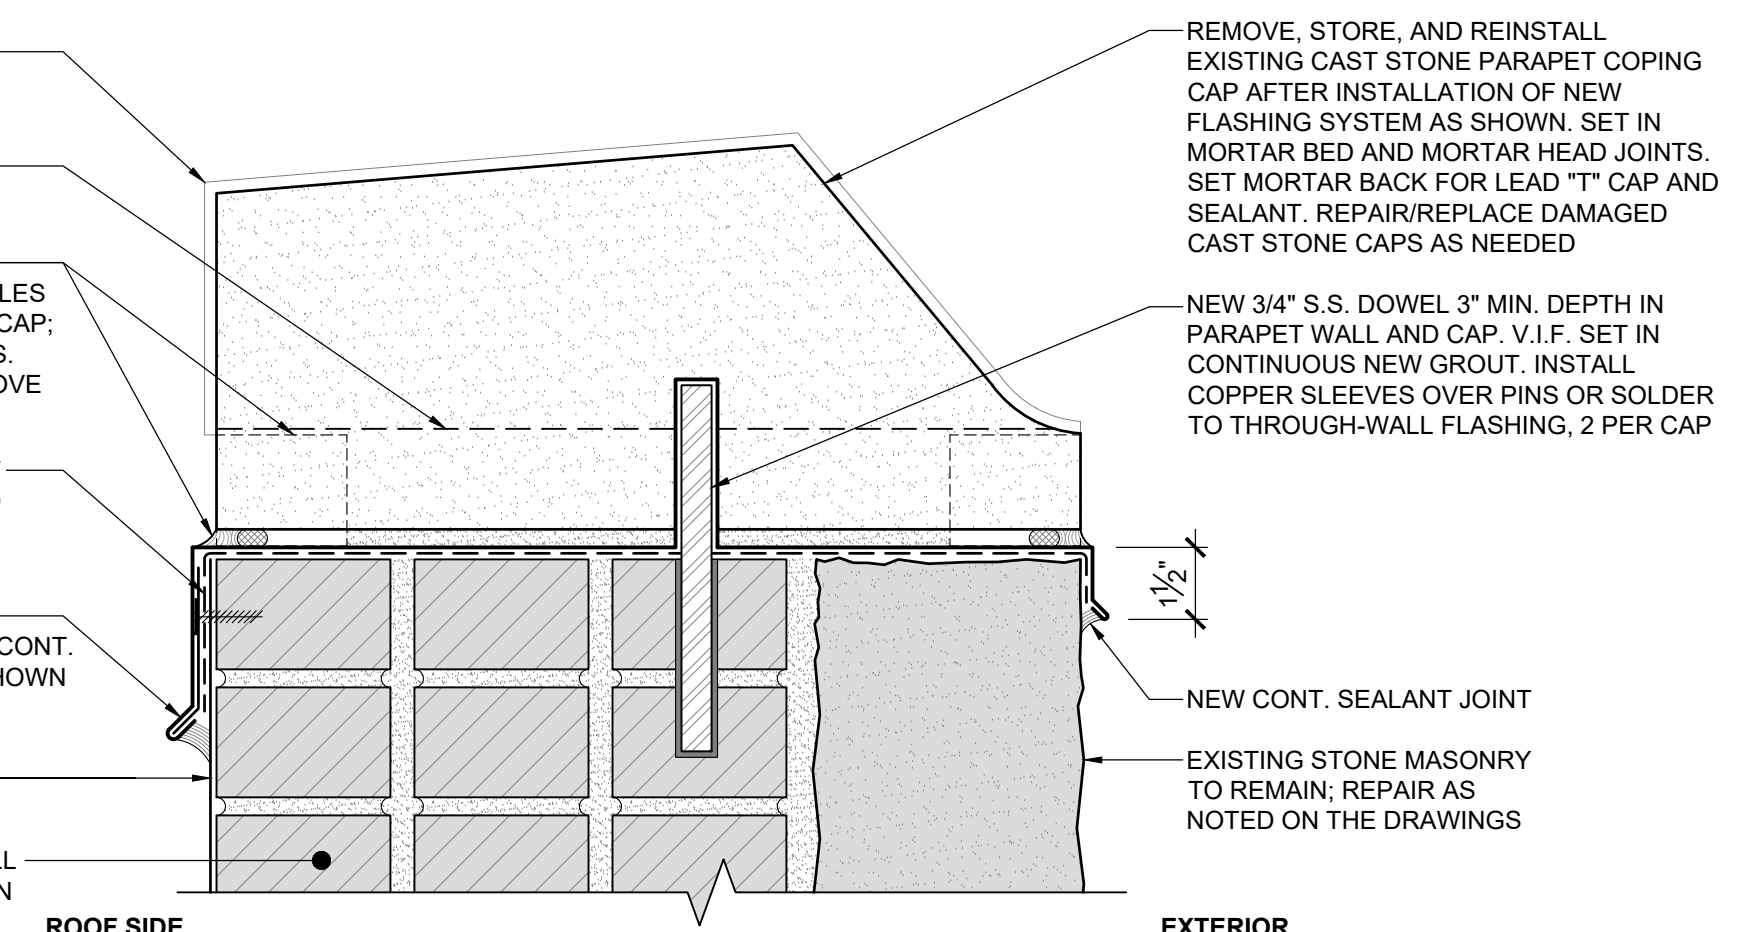
EXISTING COPPER FLASHING TO REMAIN; REPAIR AS NEEDED

EXISTING BACKUP MASONRY WALL TO REMAIN - V.I.F. CONSTRUCTION AND REPAIR AS NEEDED

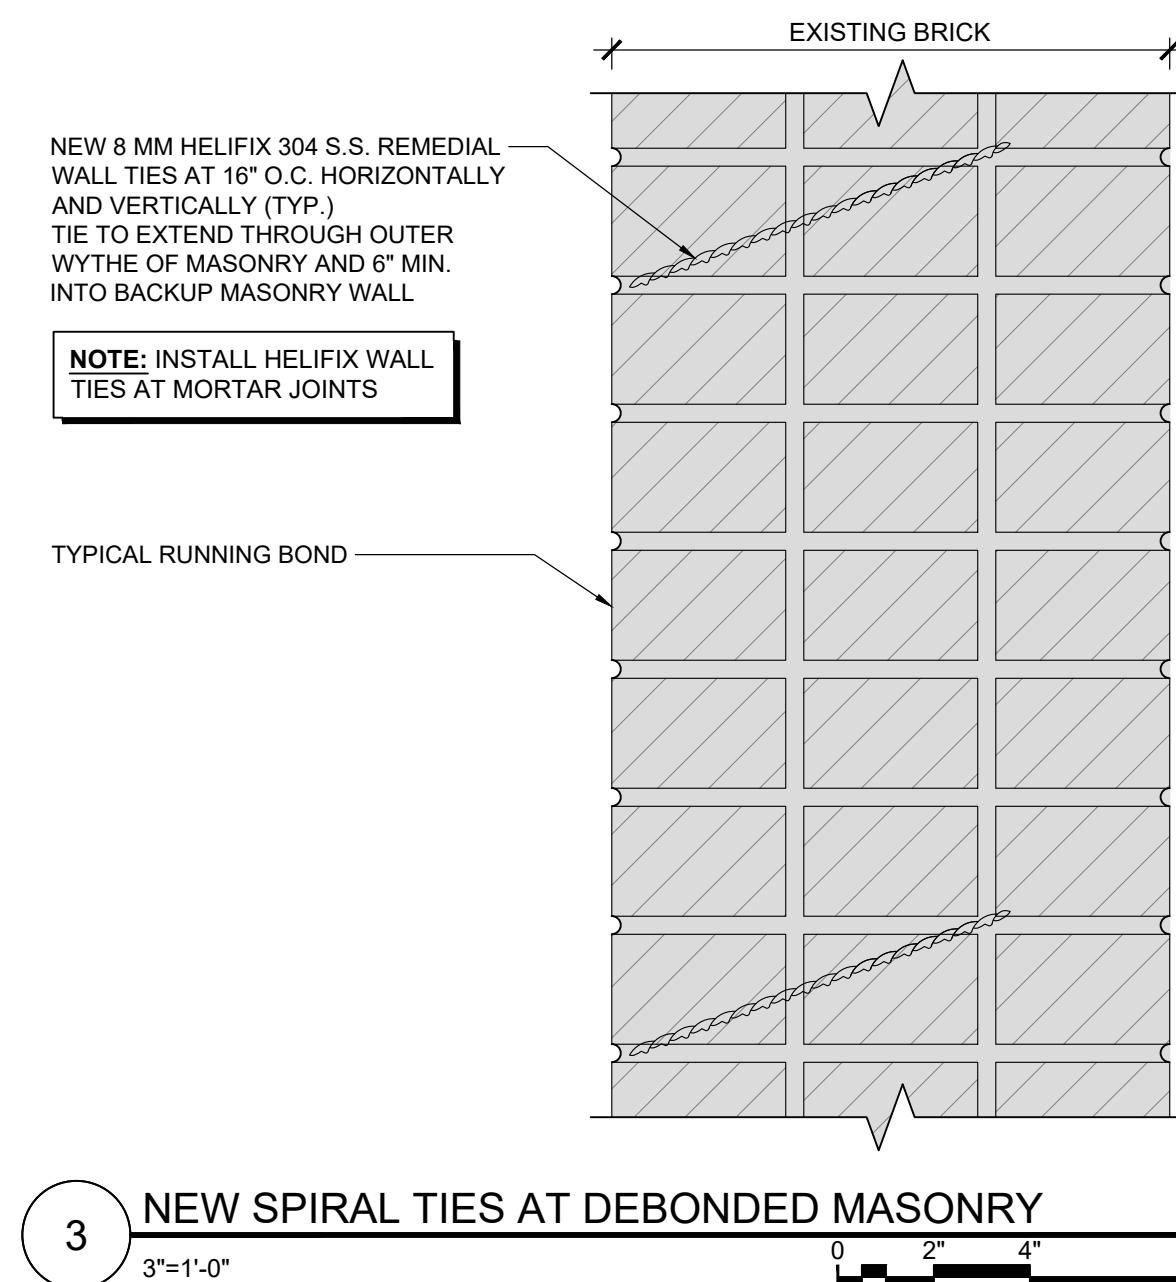
3 NEW SPIRAL TIES AT DEBONDED MASONRY
3\"/>

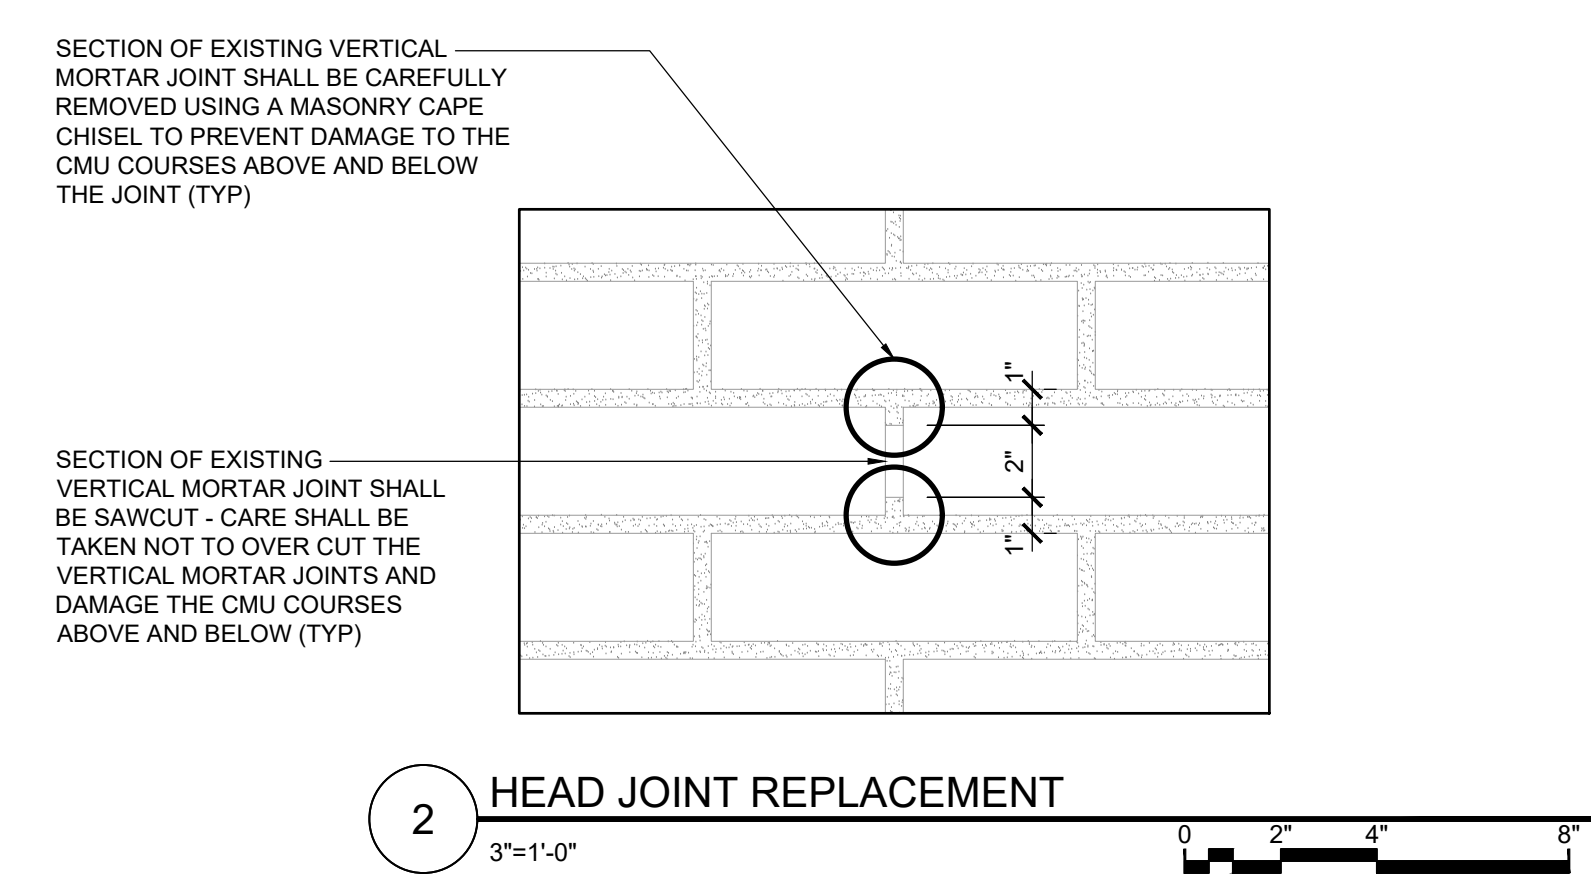
2 HEAD JOINT REPLACEMENT
3\"/>

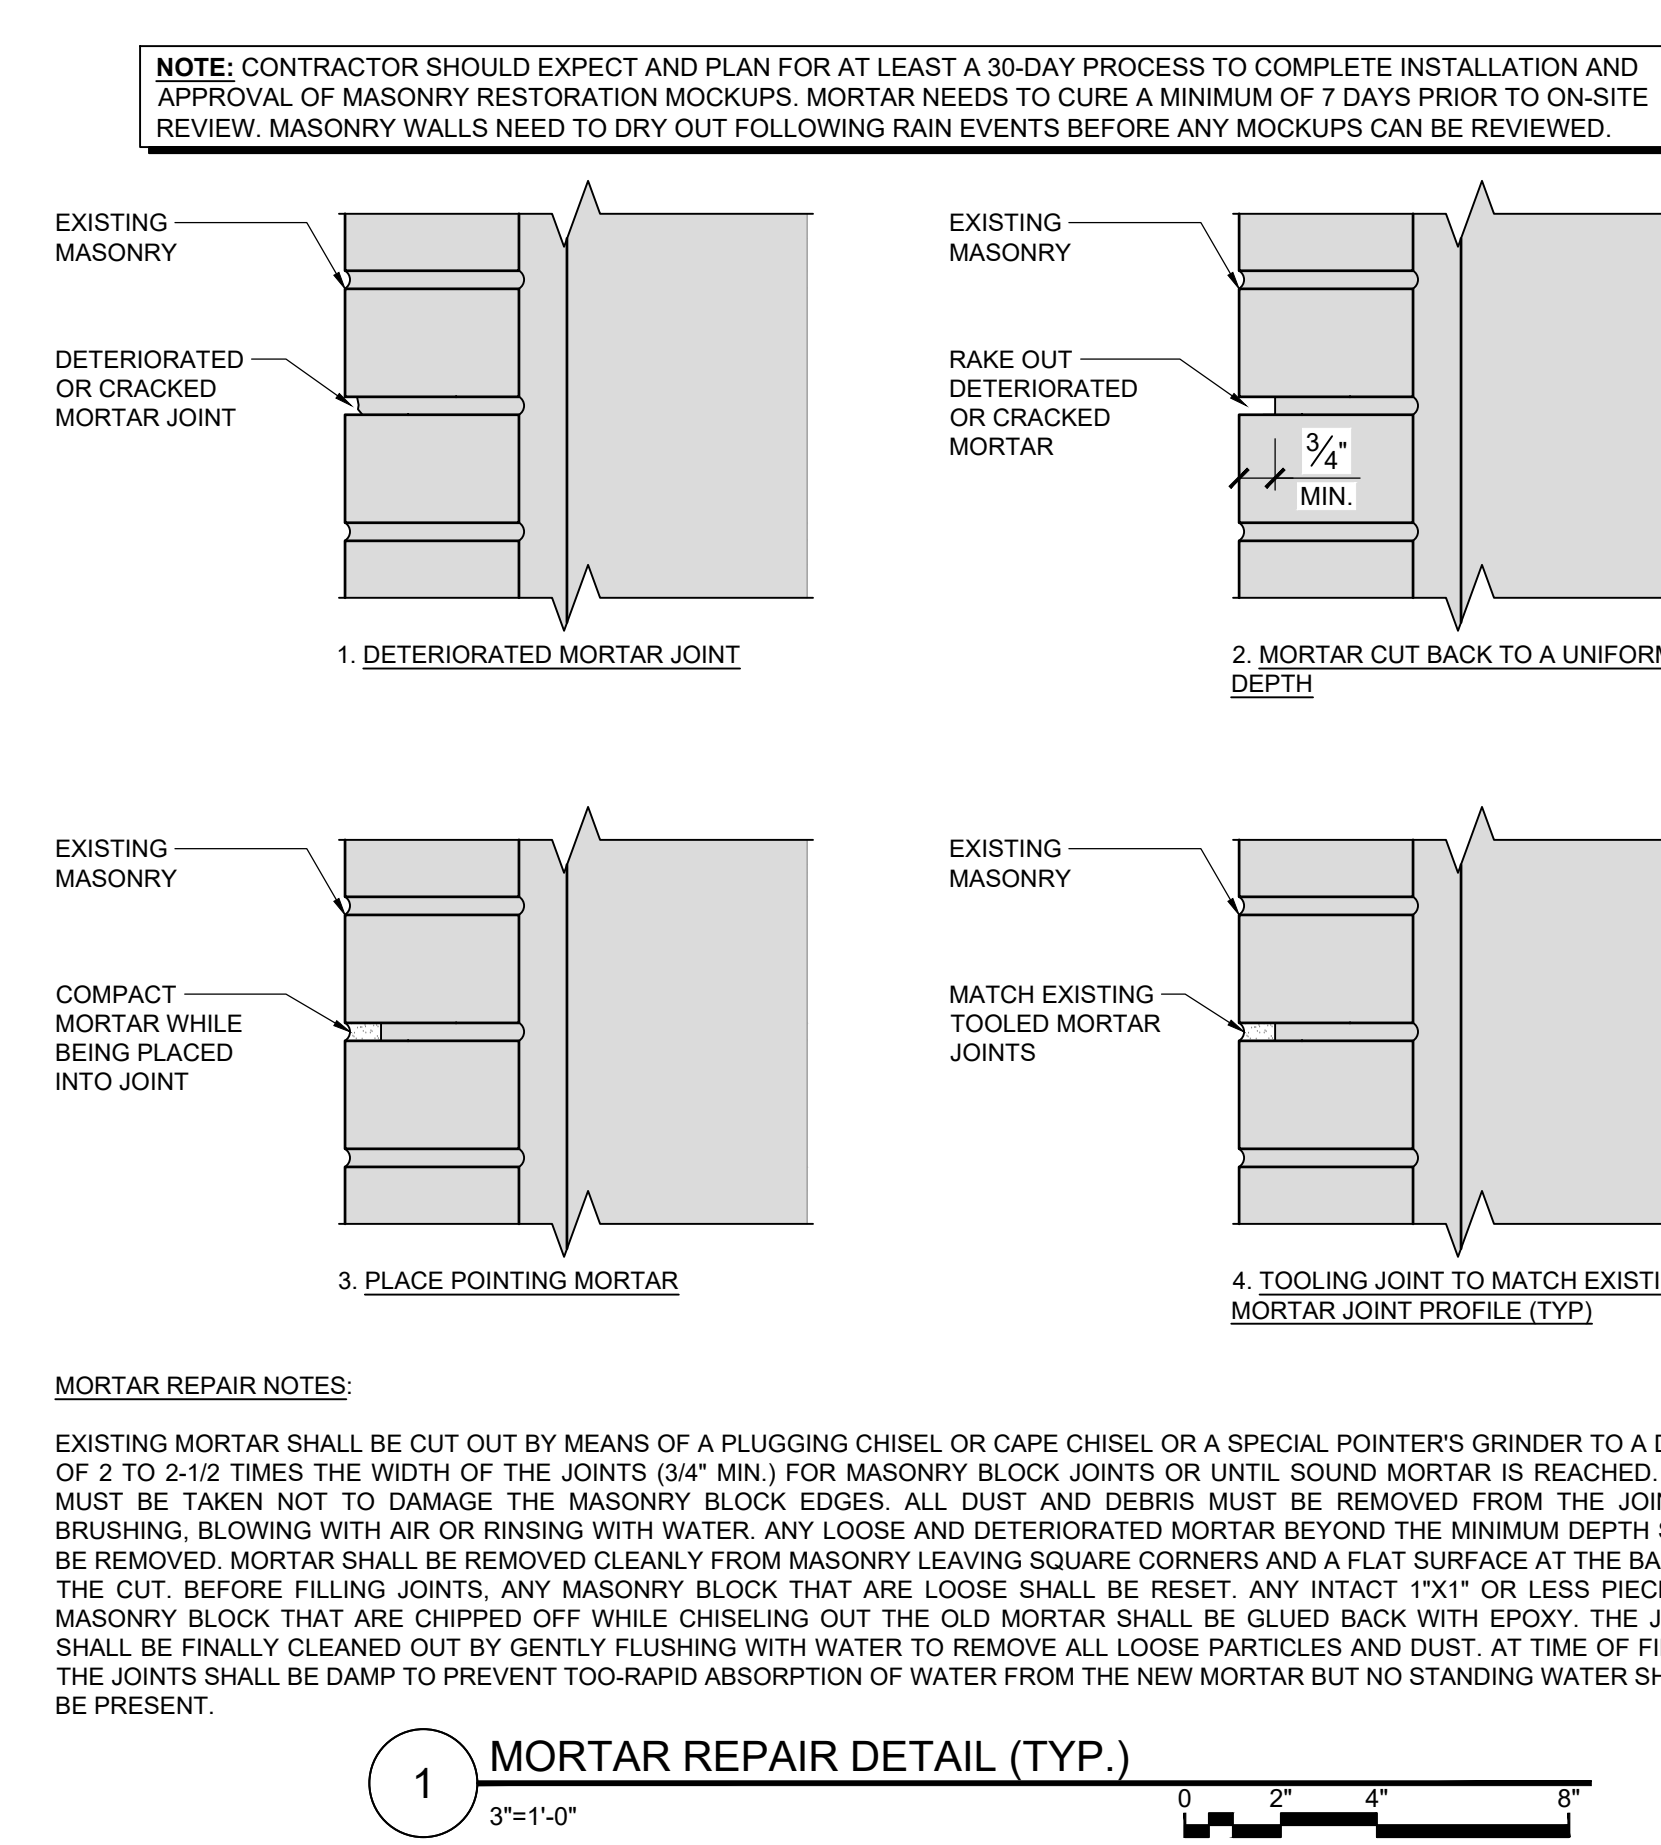
1 MORTAR REPAIR DETAIL (TYP.)
3\"/>

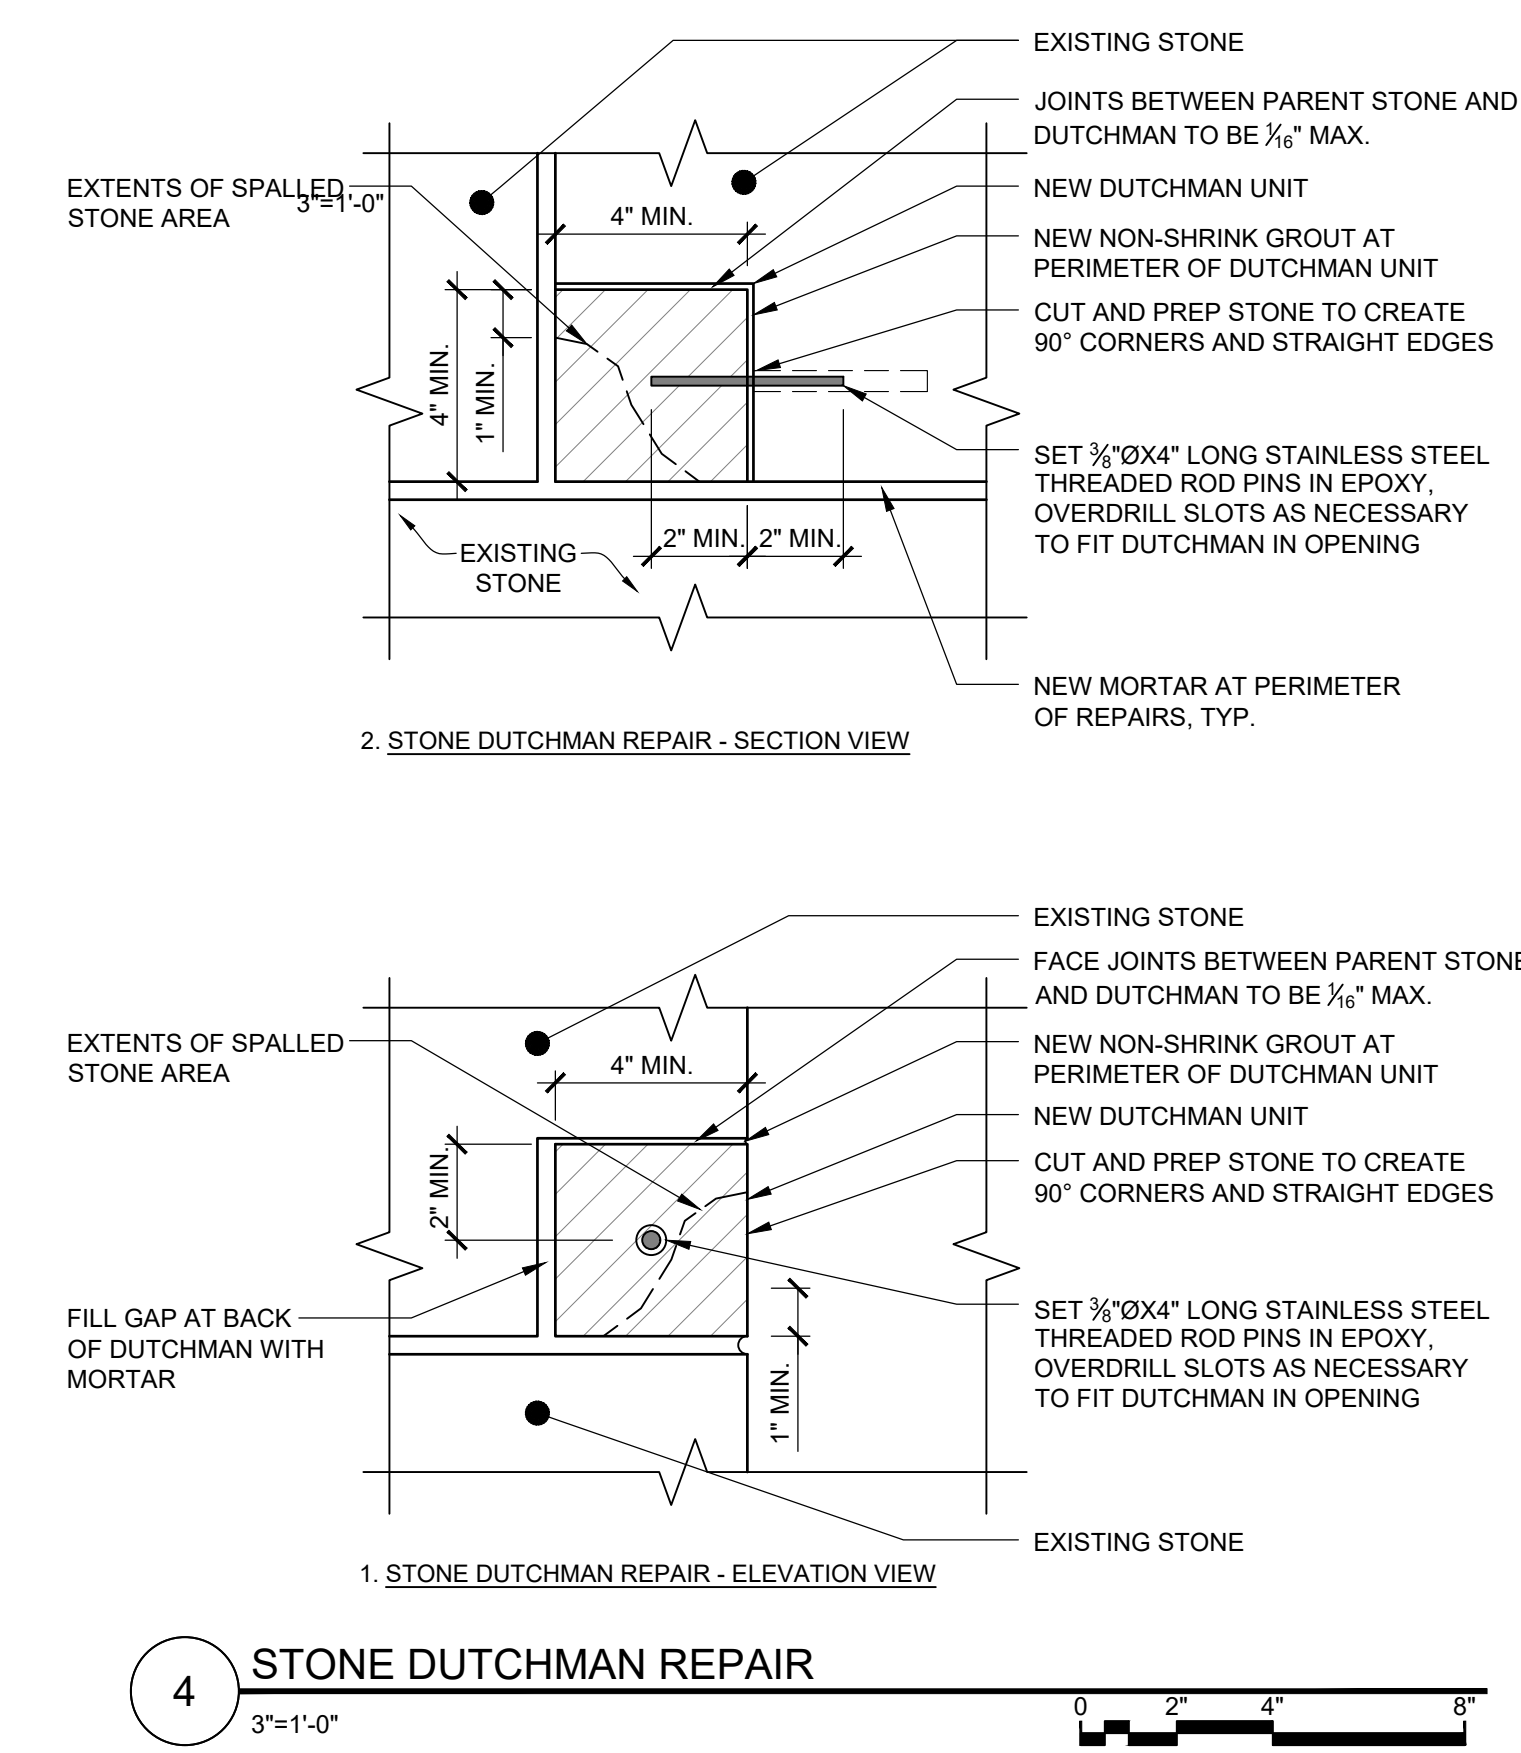
4 STONE DUTCHMAN REPAIR
3\"/>

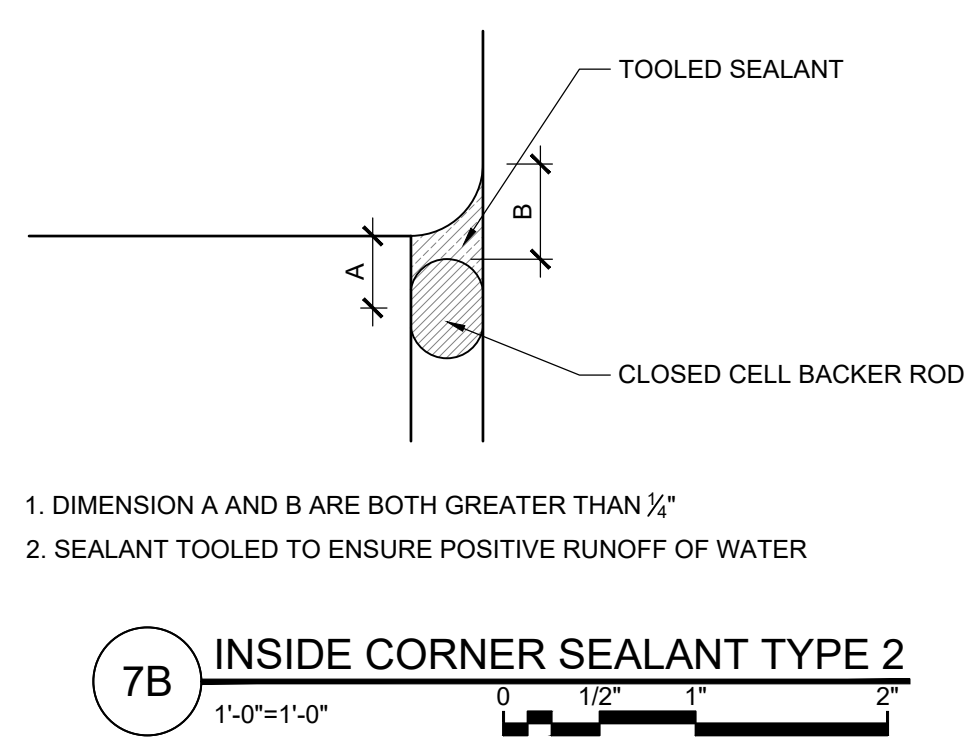
7B INSIDE CORNER SEALANT TYPE 2
1\"/>

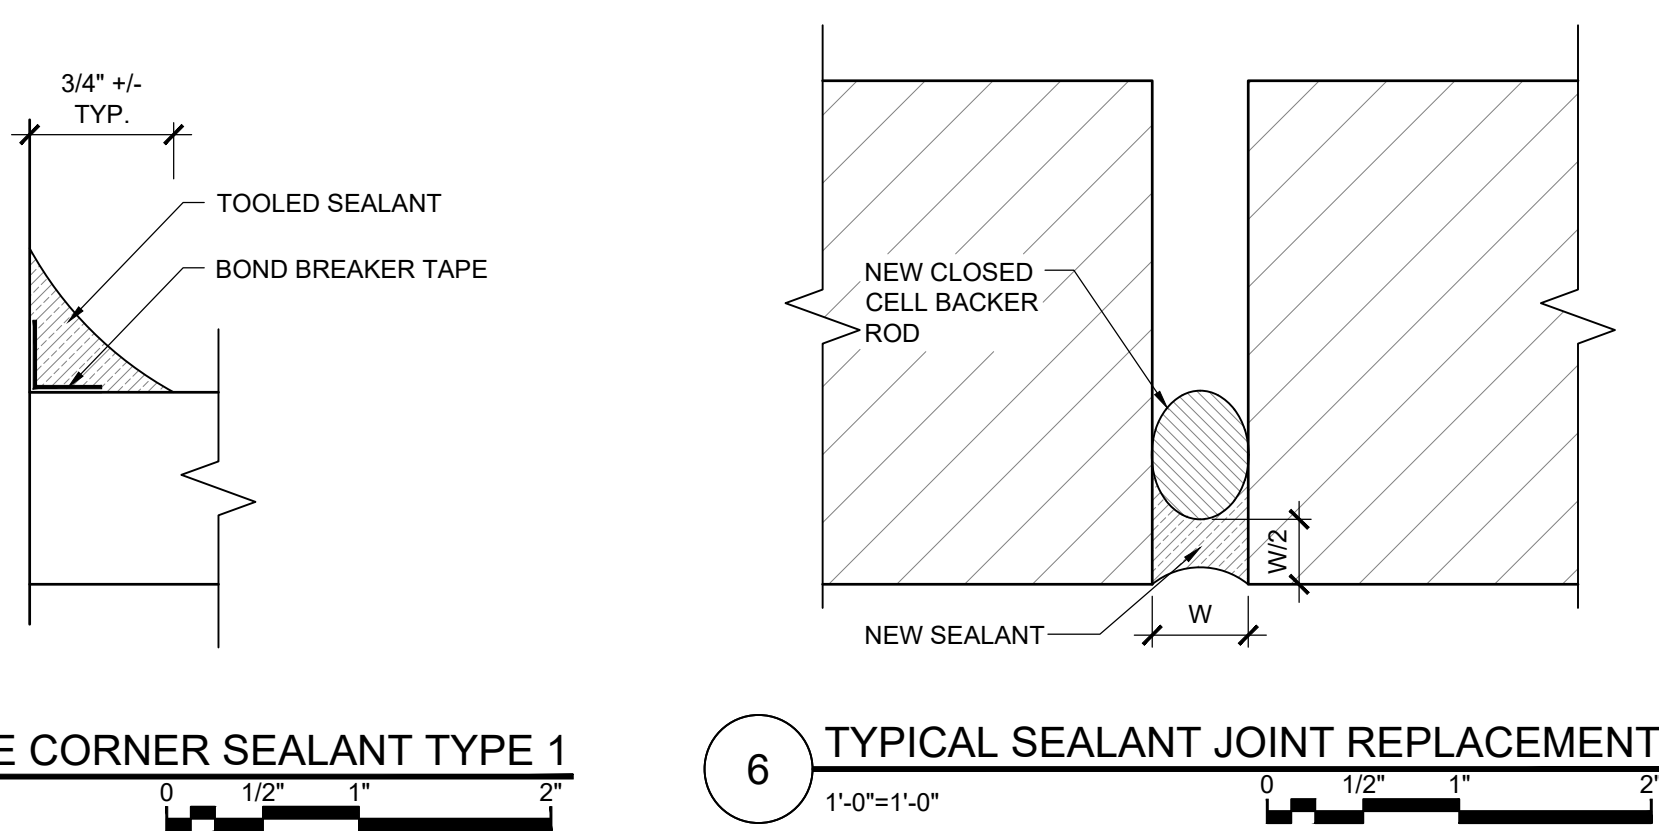
6 TYPICAL SEALANT JOINT REPLACEMENT
1\"/>

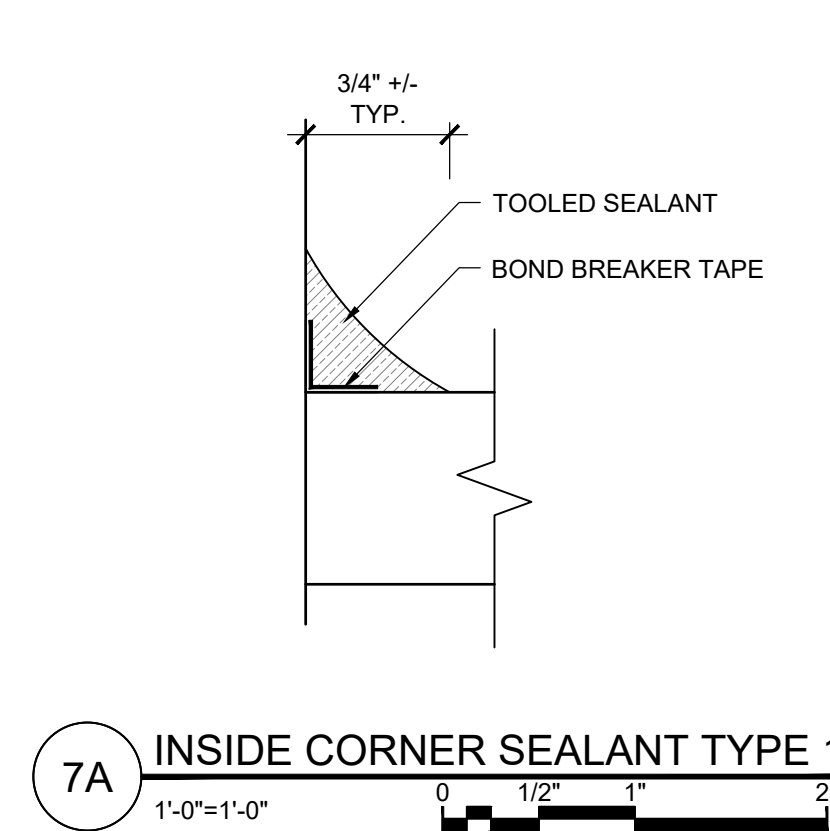
7A INSIDE CORNER SEALANT TYPE 1
1\"/>
